**IMPERIAL ROAD PORT BRUCE BRIDGE**  
**REPLACEMENT**

**ENVIRONMENTAL ASSESSMENT (SCHEDULE B)**  
**PROJECT FILE**

**IMPERIAL ROAD AT CATFISH CREEK**

**SEPTEMBER 2019**

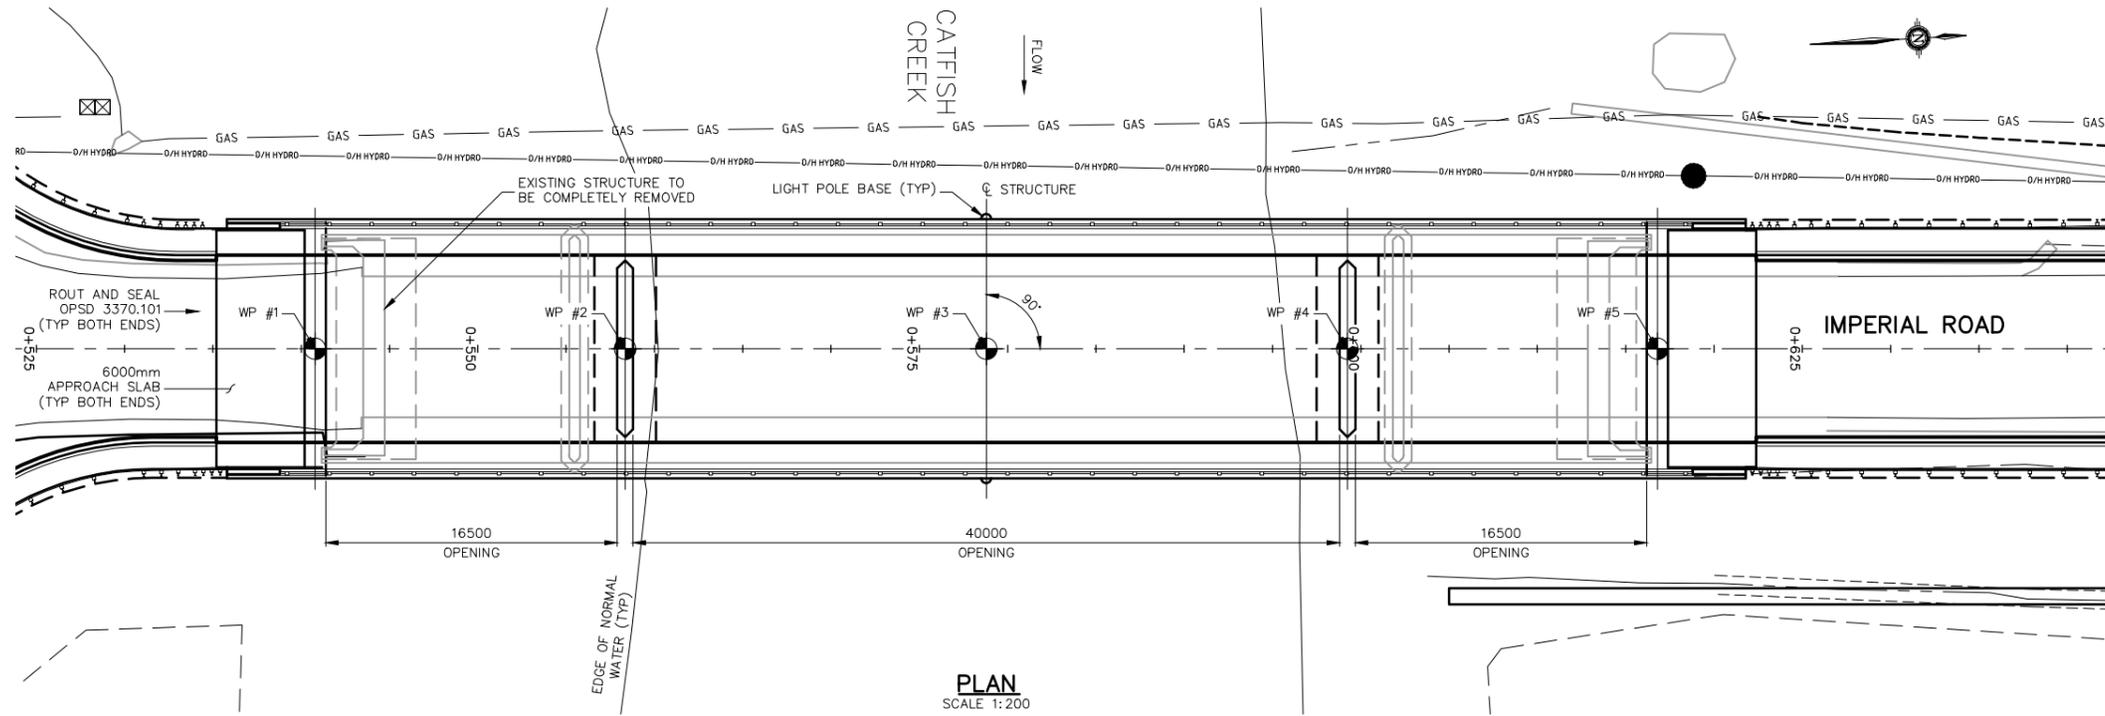
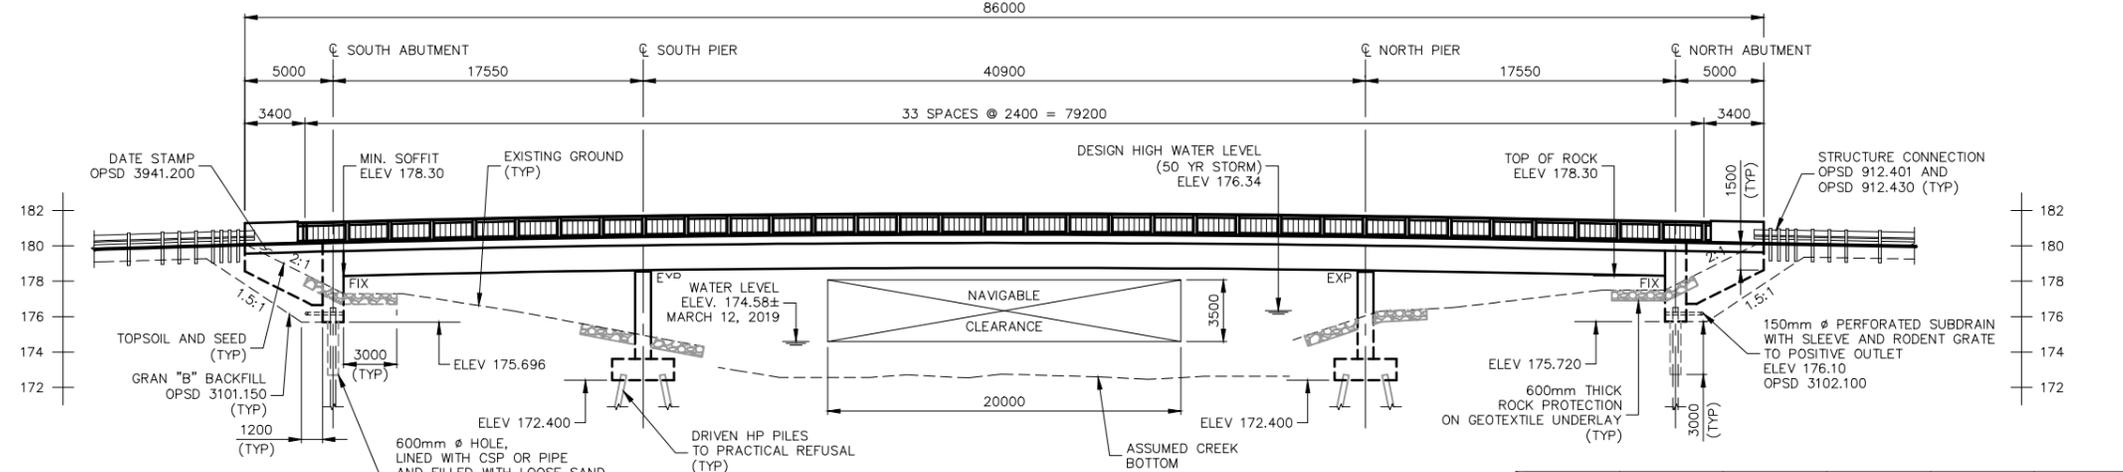
WP #1	WP #2	WP #3	WP #4	WP #5
STATION	0+540.793	0+558.343	0+578.793	0+599.243	0+616.793
ELEVATION	180.196	180.533	180.667	180.523	180.219

NOTE: WORKING POINT ELEVATIONS GIVEN TO TOP OF ASPHALT

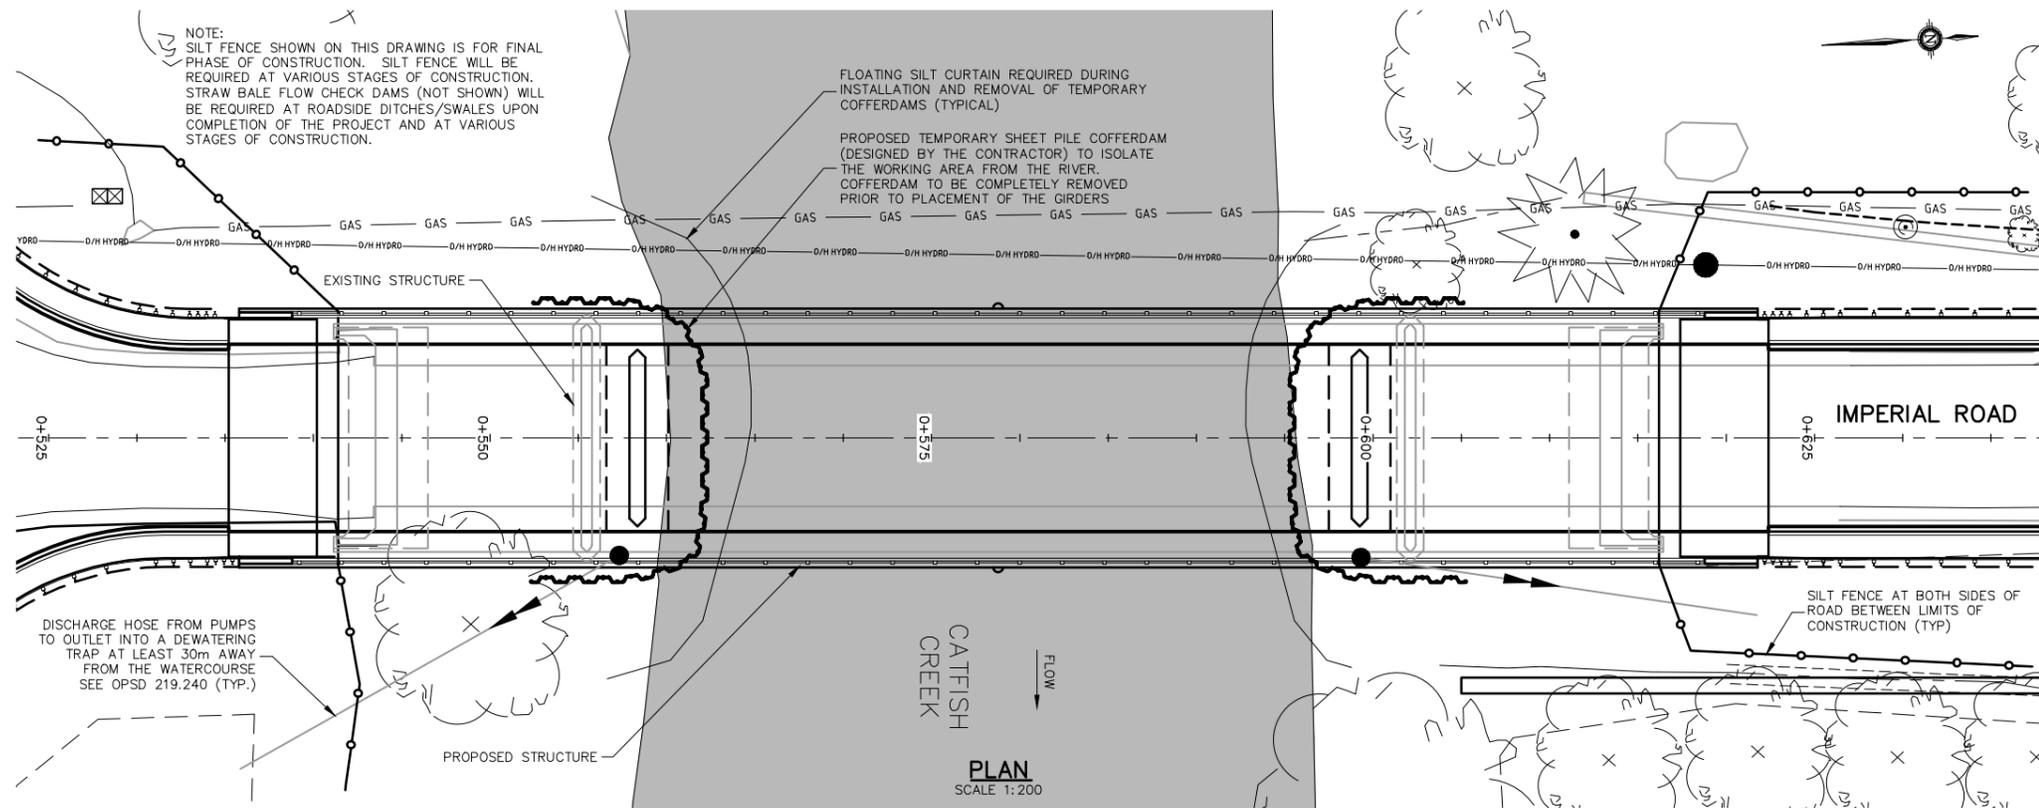
**EROSION CONTROL – BRIDGE RECONSTRUCTION**

1. ALL WORK SHALL BE DONE IN THE DRY.
2. NO IN-WATER WORK SHALL TAKE PLACE BETWEEN \_\_\_\_\_ AND \_\_\_\_\_
3. DEWATERING OF THE WORKING AREA, AND THE PLACEMENT OF CONVENTIONAL SUMP PUMPS WHERE REQUIRED. THE CONTRACTOR'S SPECIFIC METHOD SHALL BE APPROVED BEFOREHAND BY THE CONTRACT ADMINISTRATOR. ALTERNATIVE METHODS OF DEWATERING SUCH AS SHEET PILE COFFERDAMS AROUND THE ABUTMENTS MAY BE POSSIBLE PENDING THE WRITTEN APPROVAL OF THE CONTRACT ADMINISTRATOR.

1. INSTALL SILT FENCE, STRAW BALE FLOW CHECK DAMS AND ANY OTHER EROSION CONTROL MEASURES WHICH MAY BE REQUIRED.
2. PLACE FLOATING SILT CURTAINS UPSTREAM AND DOWNSTREAM OF WORKING AREA.
3. INSTALL SHEET PILE COFFERDAMS OR OTHER CONTAINMENT SYSTEM(S) AS REQUIRED.
4. DEWATER AND DE-FISH THE WORKING AREA SIMULTANEOUSLY.
5. COMPLETE DEMOLITION AND REMOVAL OF THE EXISTING BRIDGE SUBSTRUCTURE.
6. EXCAVATE AS REQUIRED IN ORDER TO CONSTRUCT NEW FOUNDATIONS, ABUTMENTS, AND PIERS.
7. PLACE BACKFILL AS REQUIRED ON BOTH SIDES OF ABUTMENTS AND PIERS TO FACILITATE REMOVAL OF COFFERDAMS. PLACE ROCK PROTECTION.
8. REMOVE COFFERDAMS.
9. REMOVE FLOATING SILT CURTAINS.
10. COMPLETE REMAINING CONSTRUCTION OF THE BRIDGE.
11. COMPLETE ROADWORK.
12. INSTALL PERMANENT SILT FENCE AND STRAW BALE CHECK DAMS.

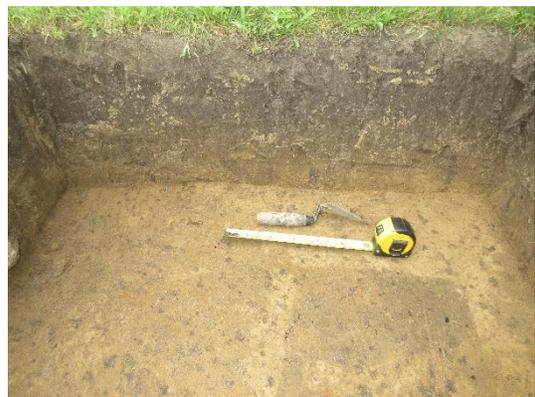
**Photo 12: Stratigraphy of Stage 3 Unit 215E, 503N at P4 (AdHg-8), facing west**

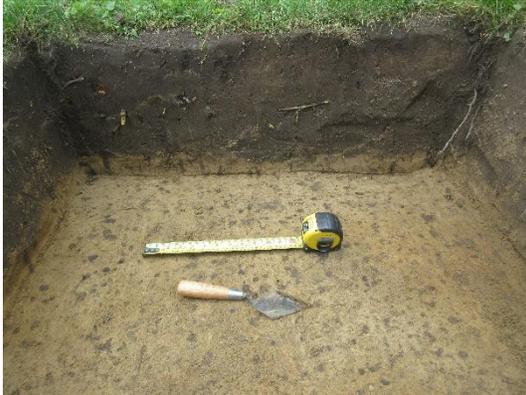
**Photo 13: Stratigraphy of Stage 3 Unit 215E, 508N at P4 (AdHg-8), facing west**

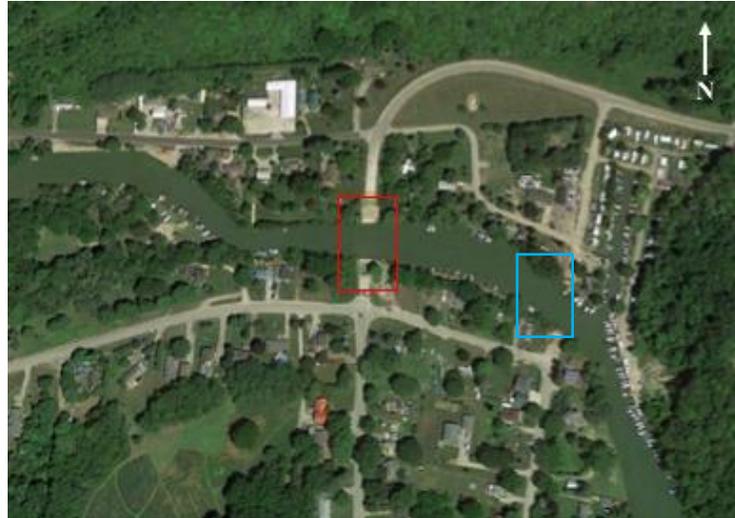
**Figure 1:** View of the Site located along Imperial Rd, Aylmer, County of Elgin, Ontario N5H 2R2. The approximate footprint of the project is located within the red rectangle. The location of the temporary bridge is located approximately 150 m downstream, within the blue rectangle. Aerial imagery was obtained from a public database (i.e. Google Earth).

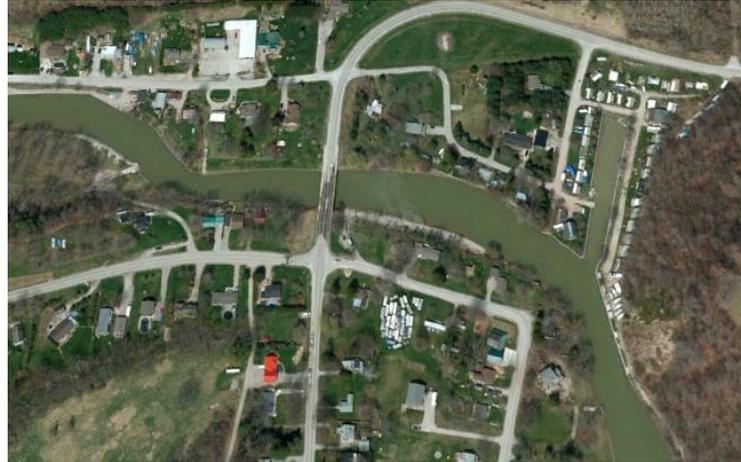
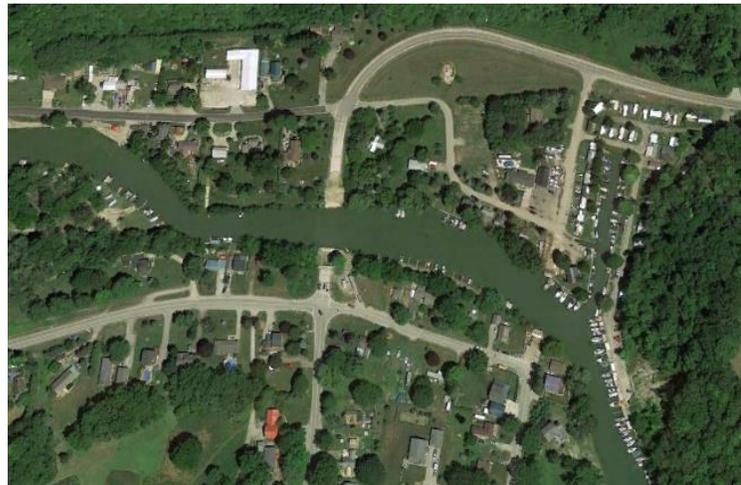
**Figure 2:** Plate 1 displays an aerial view of the Site in 2006. Plate 2 displays an aerial view from 2018.

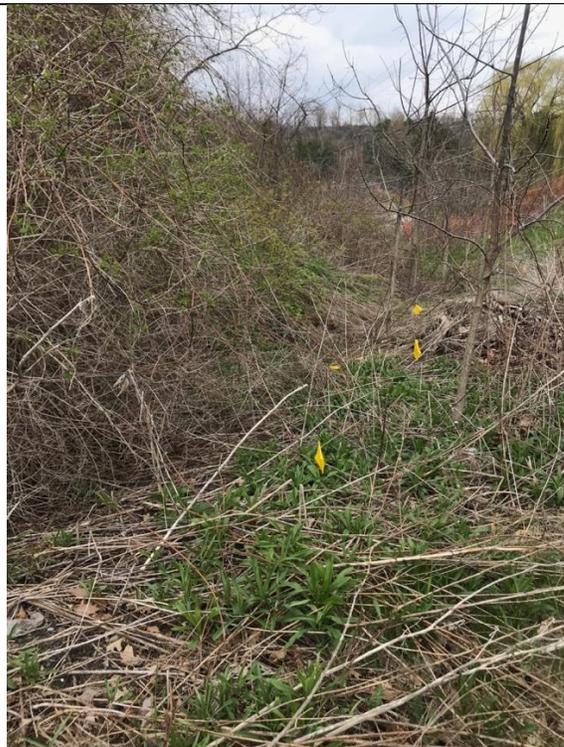
<b>Photo No. 6</b>

<b>Date:</b> May 6, 2019		
<b>Description:</b> A closer view of drainage path on the western side of the southern abutment. Vegetation tolerant of moist soil was documented along this drainage from the roadside of Dexter Line to Catfish Creek.

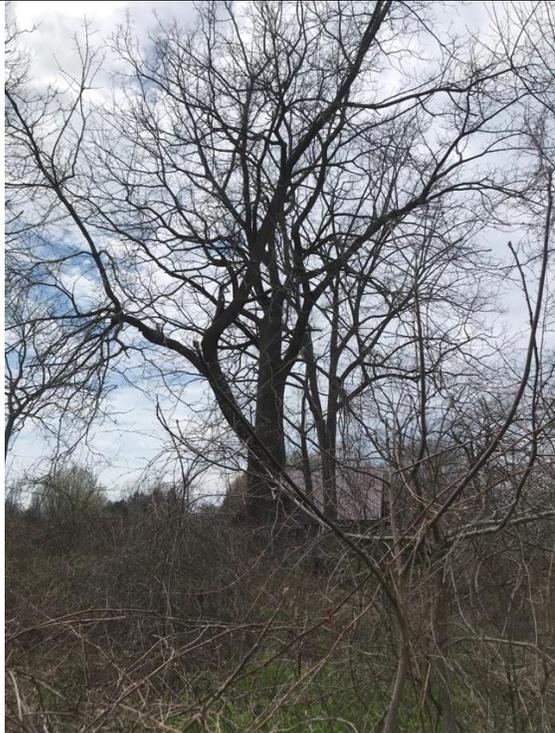
<b>Photo No. 7</b>

<b>Date:</b> May 6, 2019		
<b>Description:</b> View of a large Bur Oak tree which exists near the western bank of the southern abutment of the original Port Bruce Bridge.

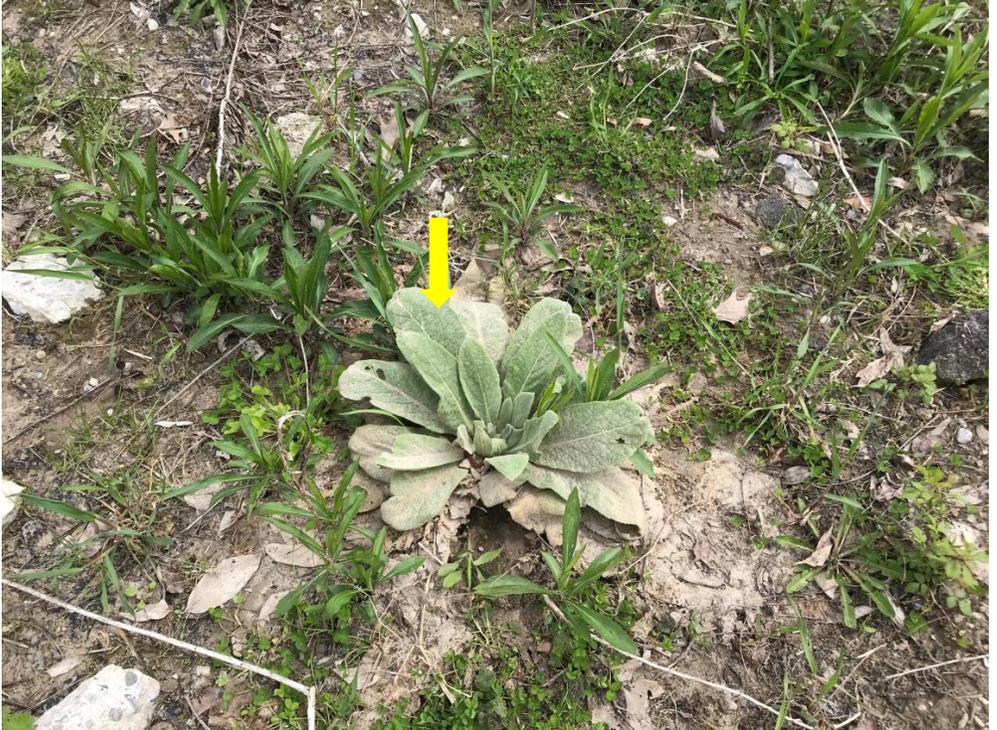
<b>Photo No. 18</b>

<b>Date:</b> May 6, 2019	
<b>Description:</b> View Great Mullein ( <i>Verbascum Thapsus</i> , marked with yellow arrow), an invasive species to Ontario. Great Mullein was observed frequently in proximity to the southern abutment. Weed control should be applied to the entire work area in the future.

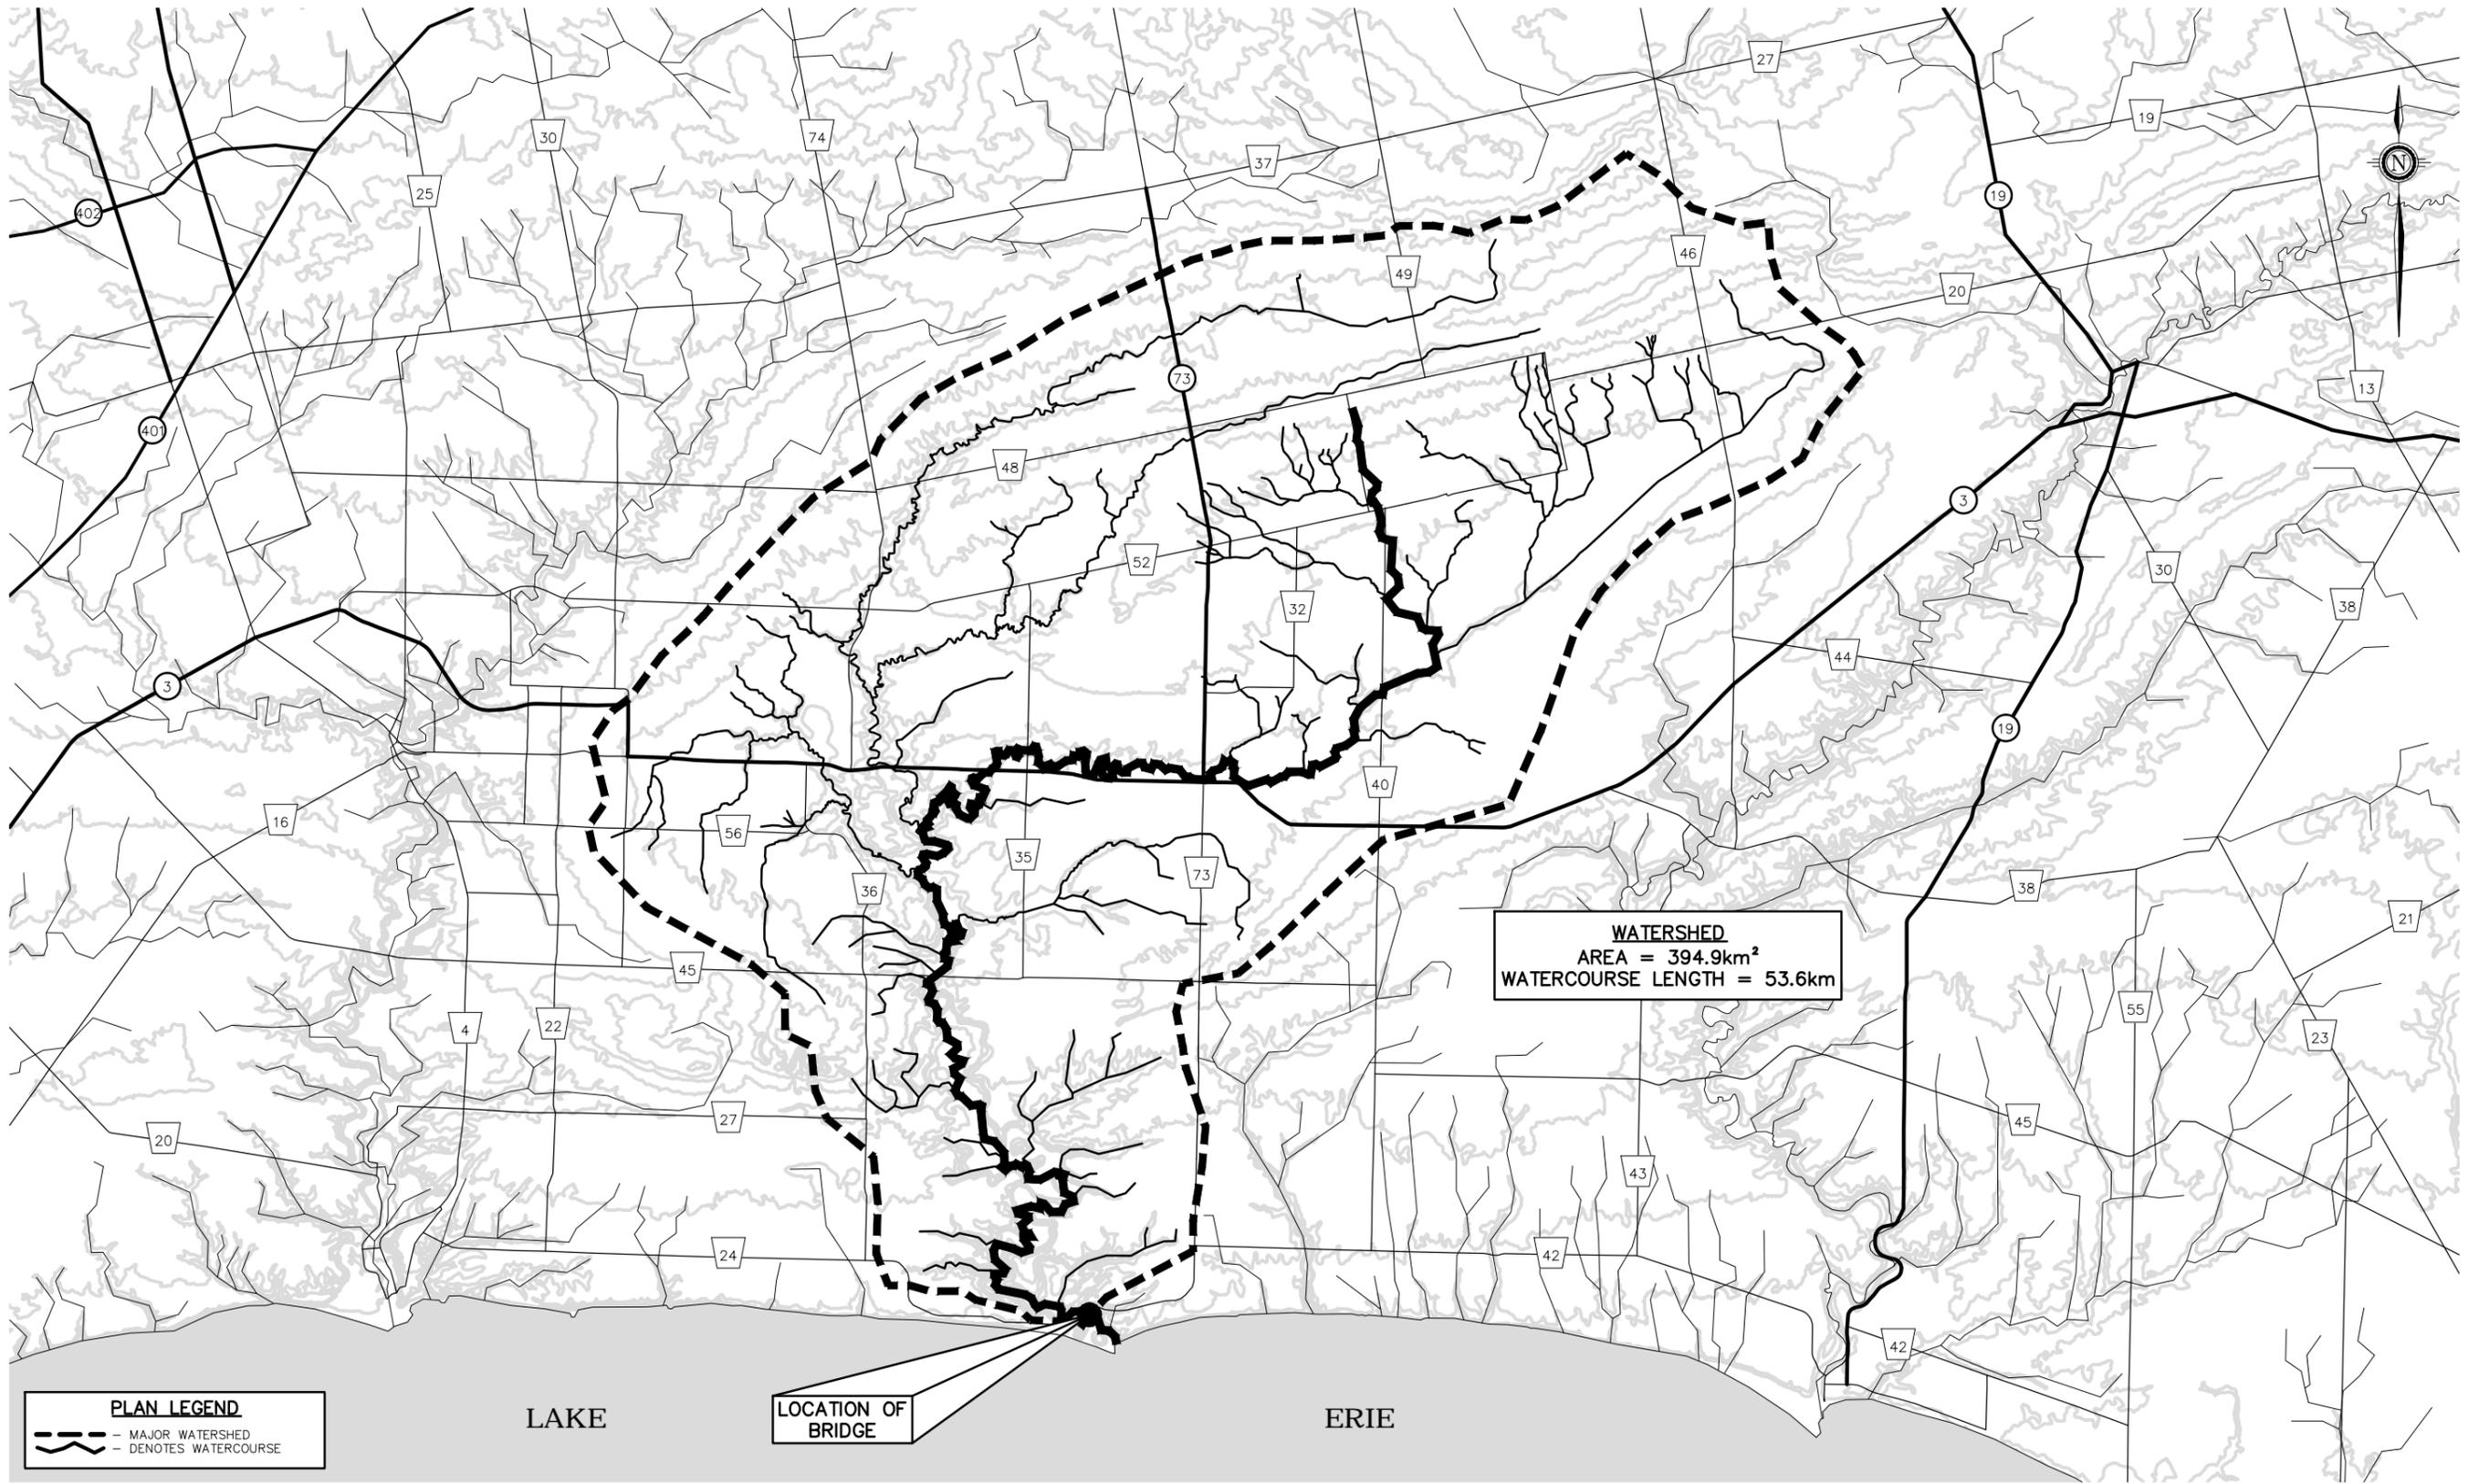
**WATERSHED**  
 AREA = 394.9km<sup>2</sup>  
 WATERCOURSE LENGTH = 53.6km

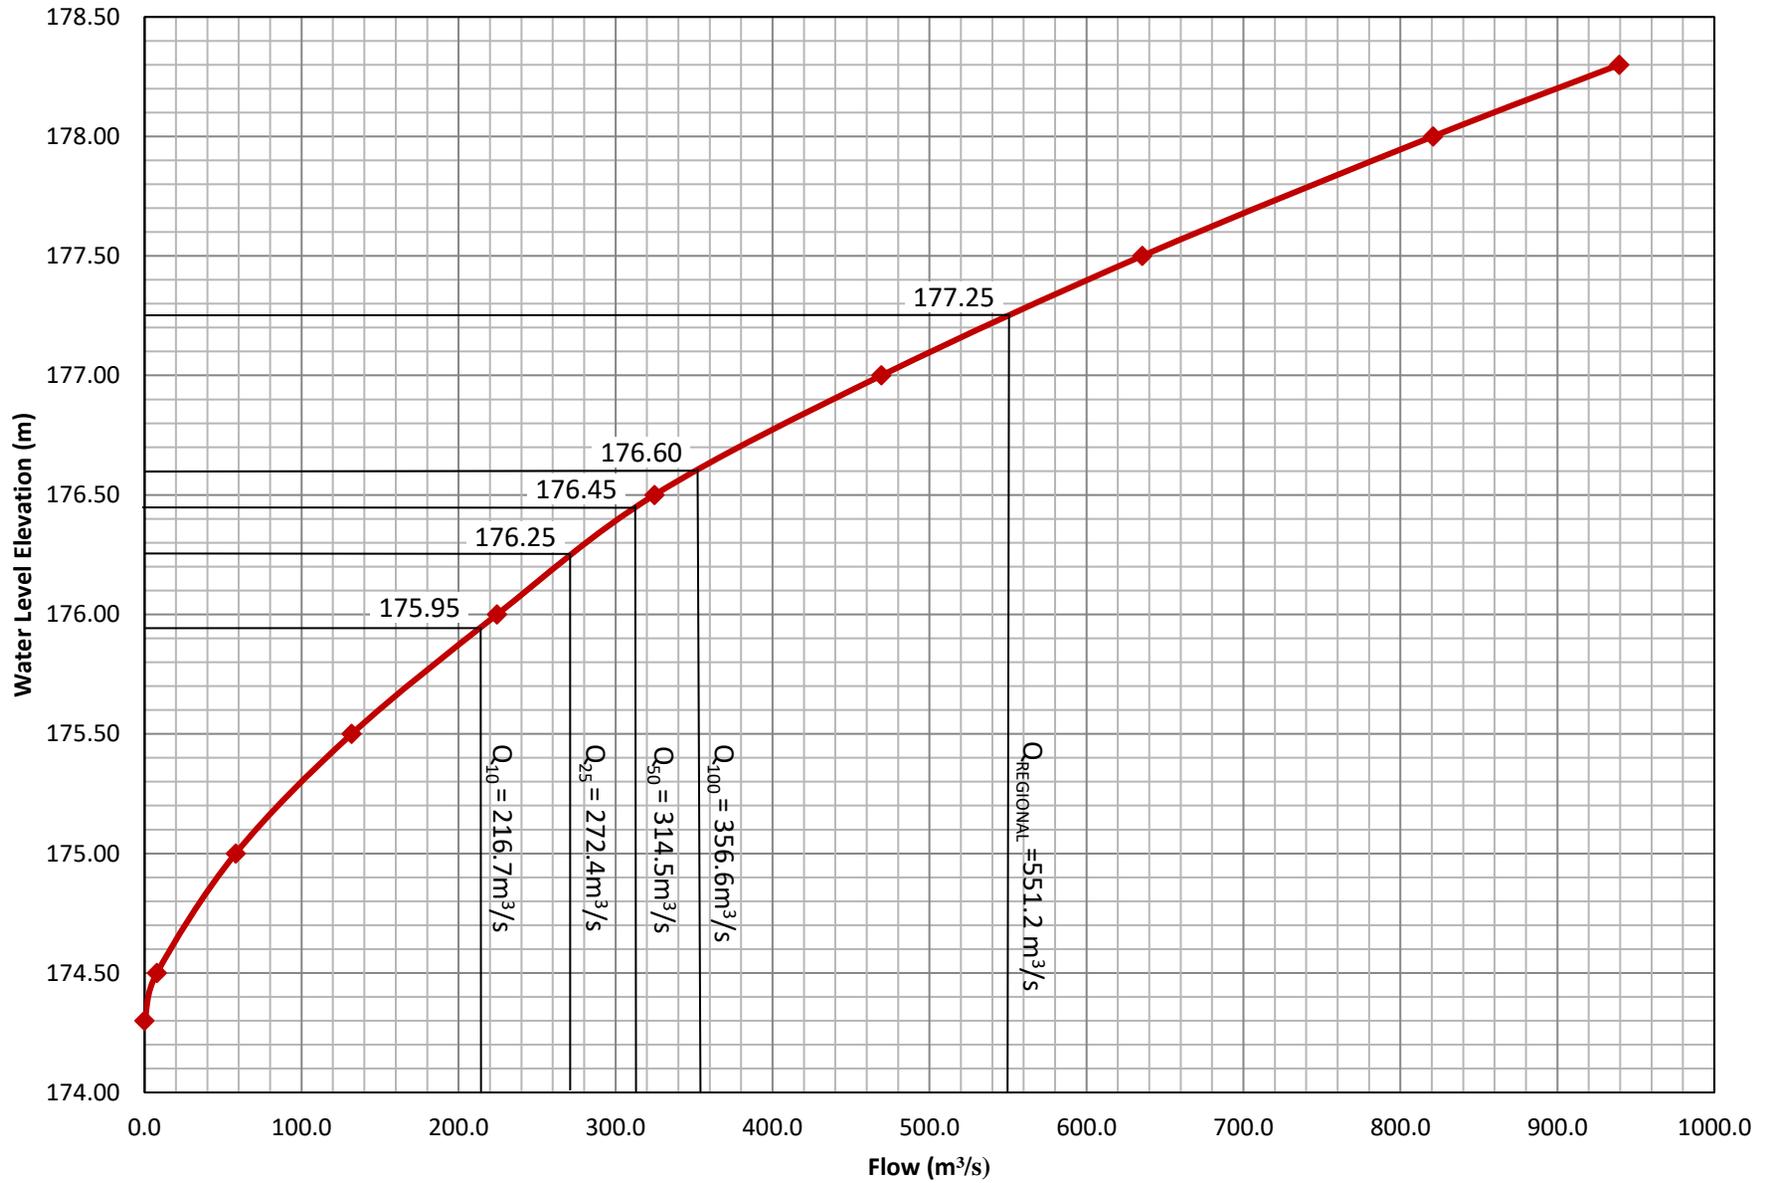
# Existing Conditions - Water Level Elevations vs. Flow

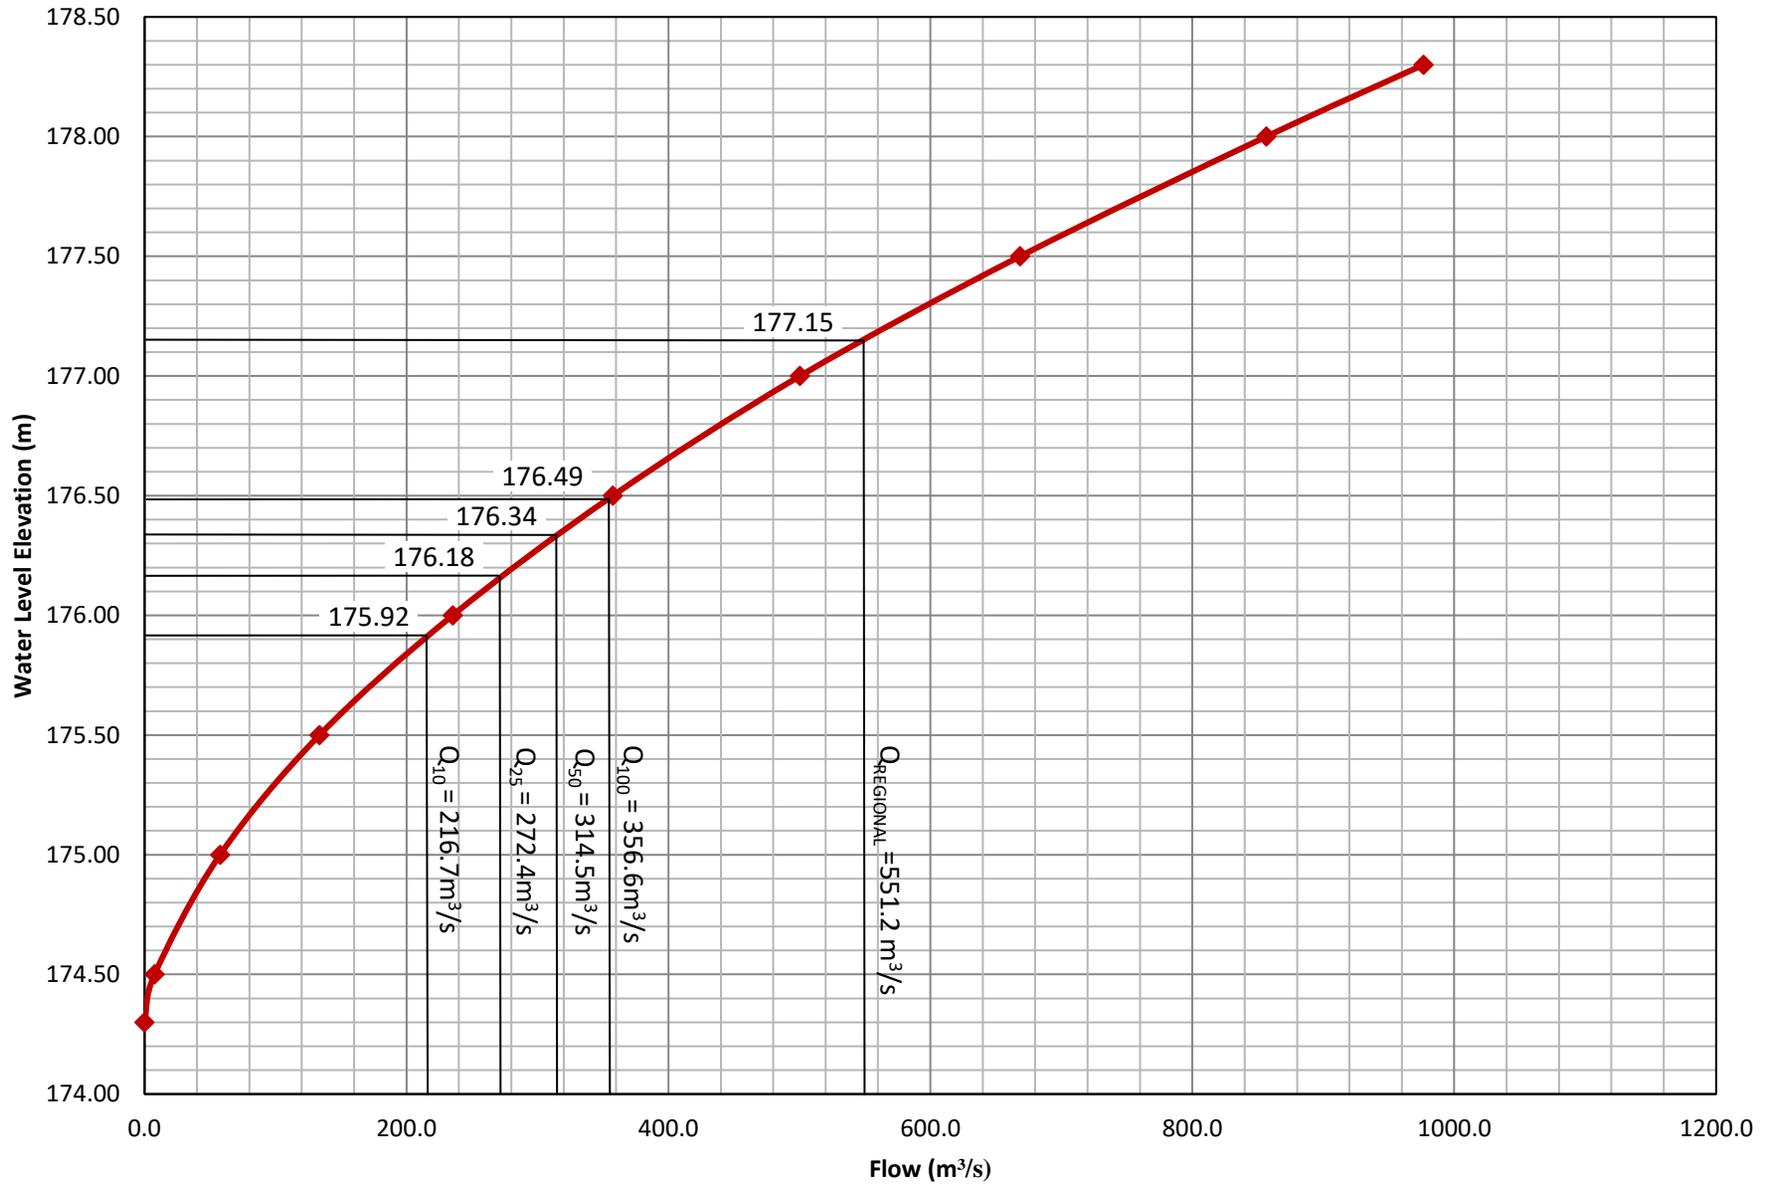
# Proposed Conditions - Water Level Elevations vs. Flow
