# Background Information & History

- ❖ Single-span double leaf bascule bridge was constructed in 1938
- East-west orientation spanning Kettle Creek
- Span of 42.7m and an overall deck length of 68.3m
- Known mechanical and electrical upgrades completed in the 1970's, early 2000's and miscellaneous inspections and repairs in recent years

### Inspection Results

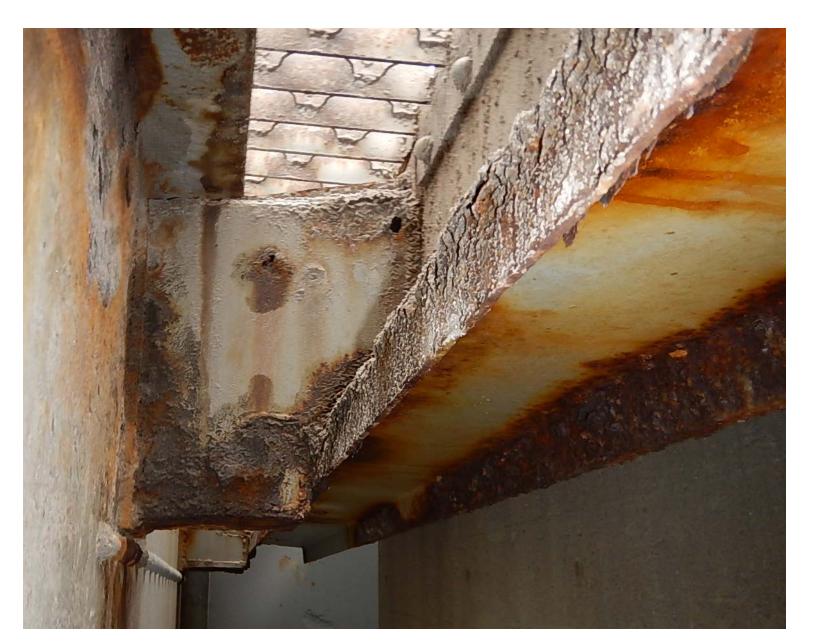
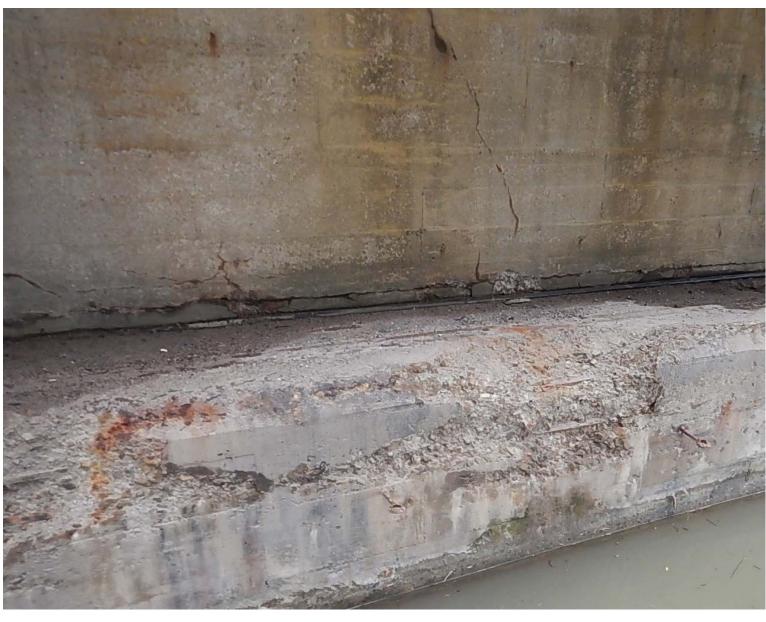
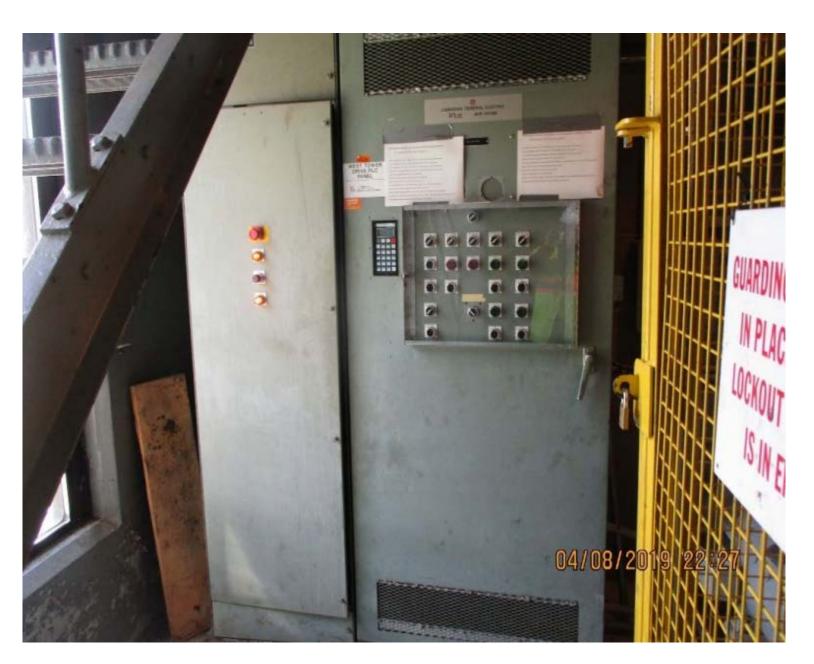
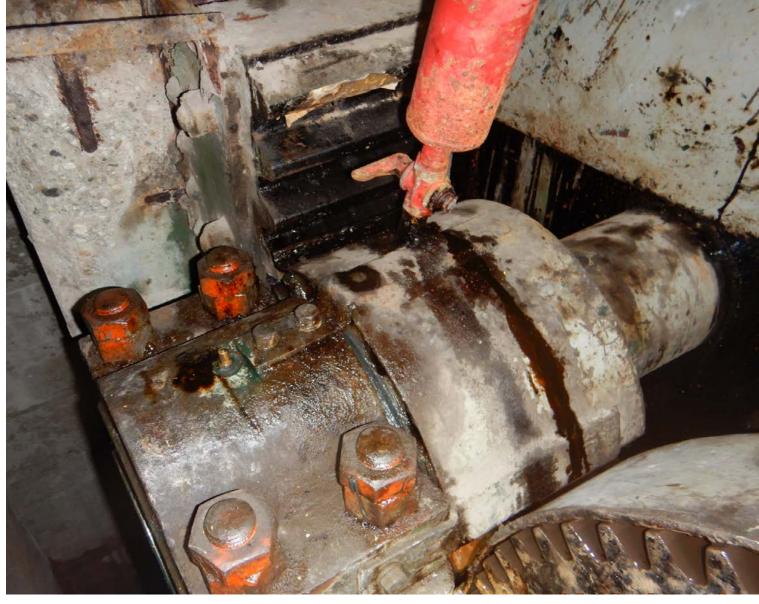
- Poor condition coatings and steel corrosion
- Concrete elements requiring repair
- Bridge requires re-balancing
- Span drive machinery is aged and in poor condition
- Electrical equipment including motor control centre (MCC) and system controls are antiquated with replacement parts mostly unavailable
- Recommend the bridge be posted with a 10-14-18 triple load posting

- Structural reinforcing on the end beams, main girders and end-bay bracing
- Partial depth concrete repairs to abutments and wingwalls
- Replacement of tower windows
- Surface treatment to sidewalks

- Replacement of span drive machinery (match existing size)
- New span lock actuators
- Bridge balancing

- Abrasive blast clean and remove existing coating system on all exposed structural steel
- Coat structural steel with a three-part coating an inorganic primer, an epoxy mid-coat and a urethane top coat
- Partial clean and paint exposed steel in the trunnion pits
- Clean and paint interior tower walls

- Replace the motor control centre (MCC) and system controls
- Install back-up power generators
- Add redundant span drive motors
- Replace traffic gates
- Upgrade facility and bridge lighting
