# Municipal Class Environmental Assessment Meeks Bridge Replacement

County of Elgin

Public Information Centre

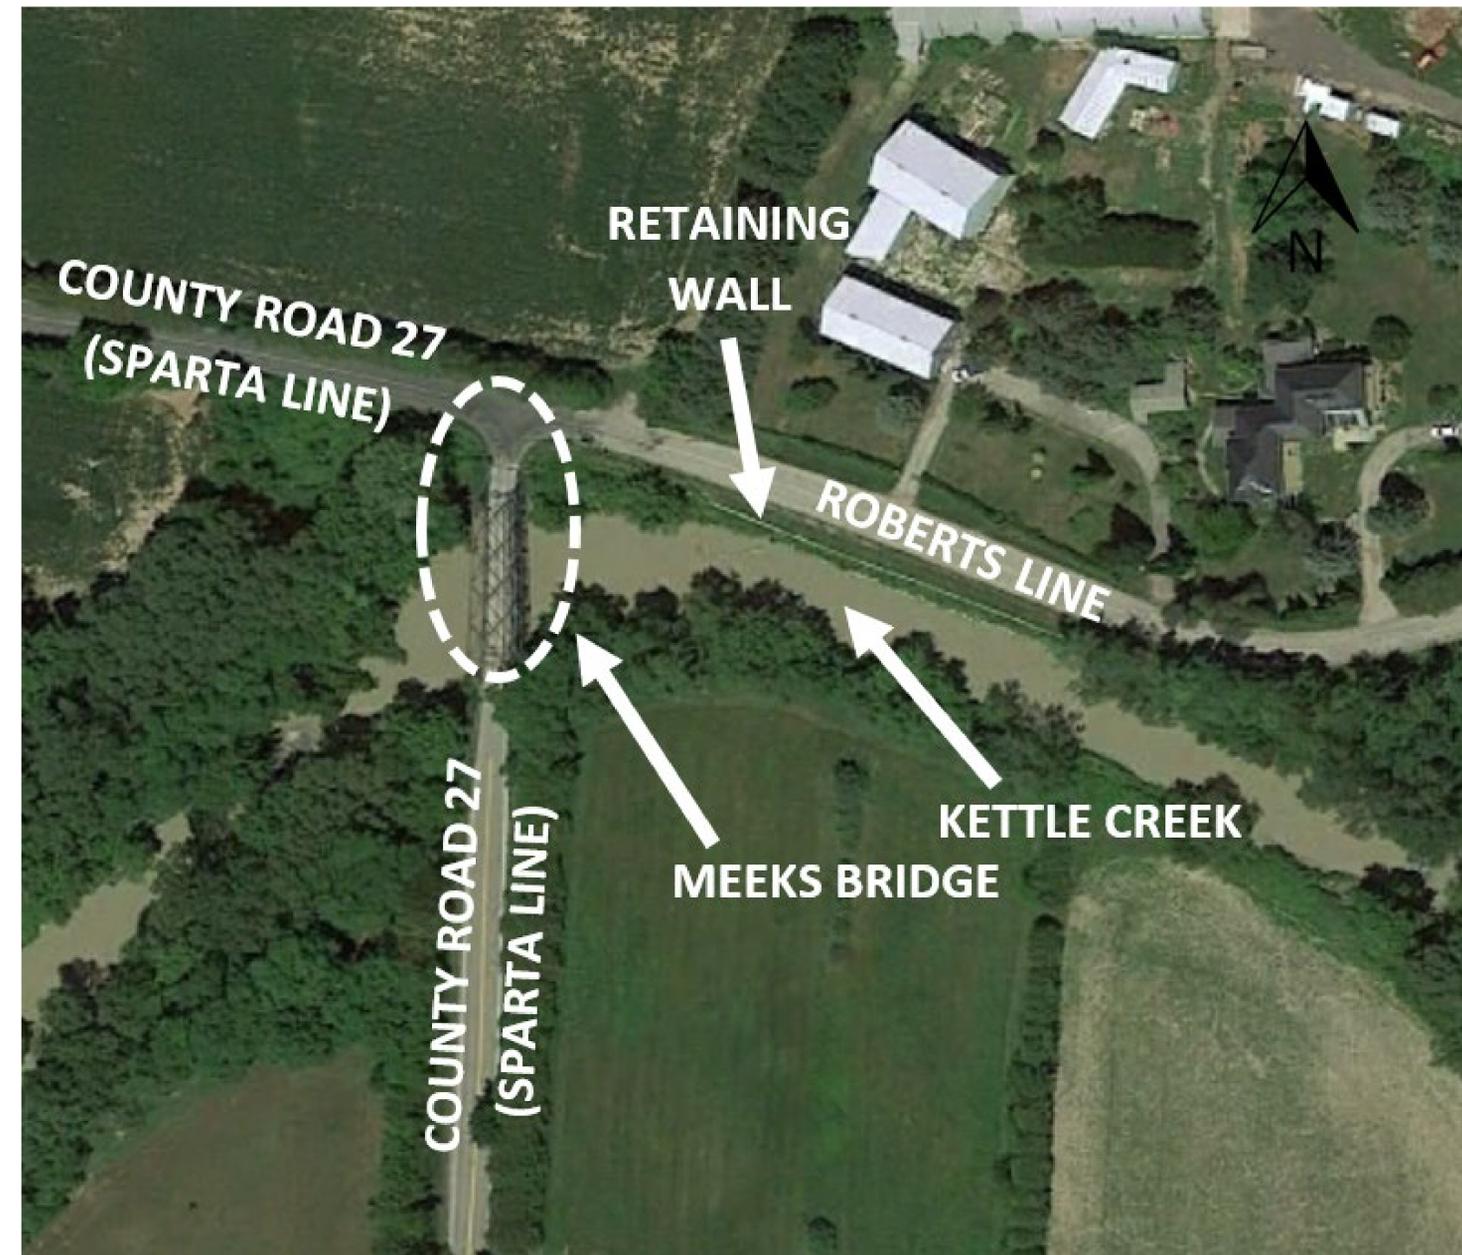
- Meeks Bridge is a single span bridge located on Sparta Line in the Township of Southwold, south of the City of St. Thomas
- Meeks Bridge was constructed in 1900 and is a steel double-intersection Warren truss (Double Warren) bridge structure that crosses Kettle Creek
- The bridge has a total deck length and width of 38.7 metre and 4.9 metres, respectively
- Just downstream of Meeks Bridge on the north bank, a 2.5 m high, 60 m long retaining wall supports the bank
- The bridge is located within the jurisdiction of the Kettle Creek Conservation Authority

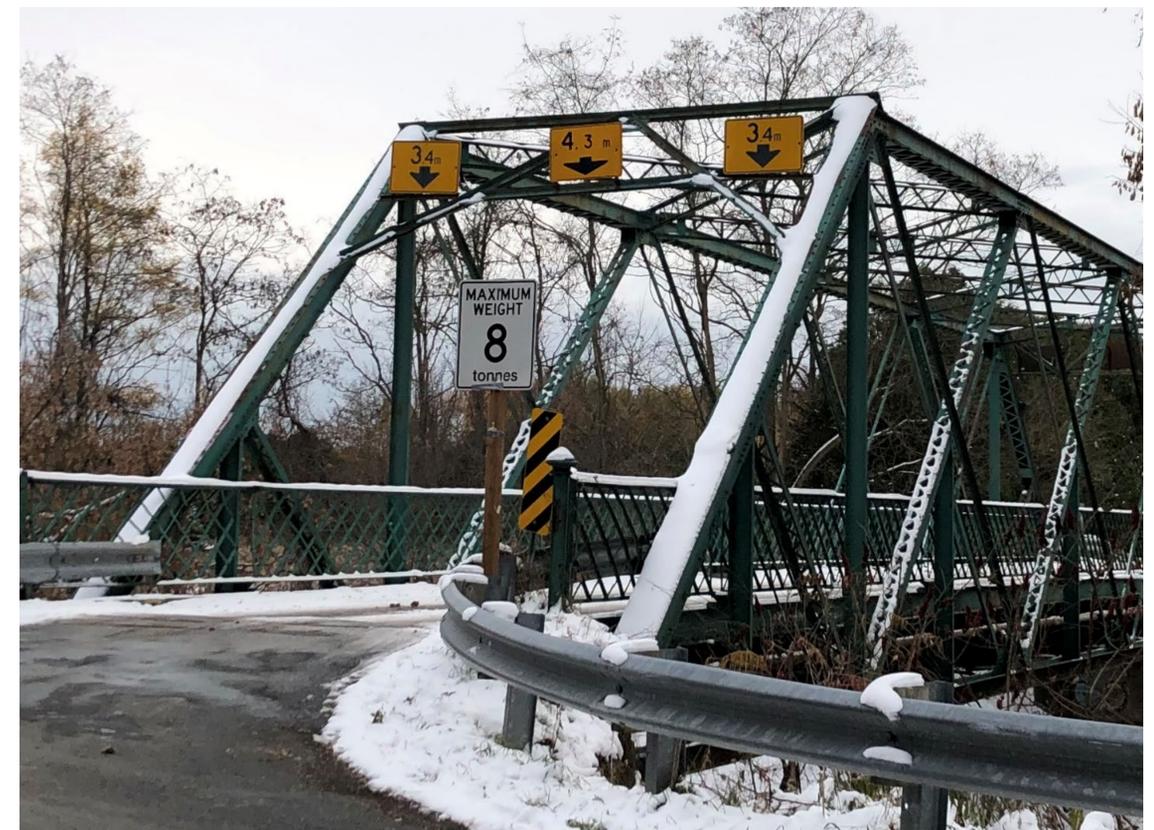
- The bridge currently has a load posting of 8 tonnes due to the structural capacity of truss bottom chords (2- C230 X 20) and transverse beams (W460 X 67).
- Underside bracing has fallen off on numerous panels and the remainder is corroded.
- The concrete deck exhibits spalling, cracking and severe scaling.

**The 2019 bridge inspection report recommended rehabilitation in 1-5 years and replacement in 6-10 years.**

**Overall, Meeks Bridge is in poor structural condition and is in need of replacement or reconstruction.**

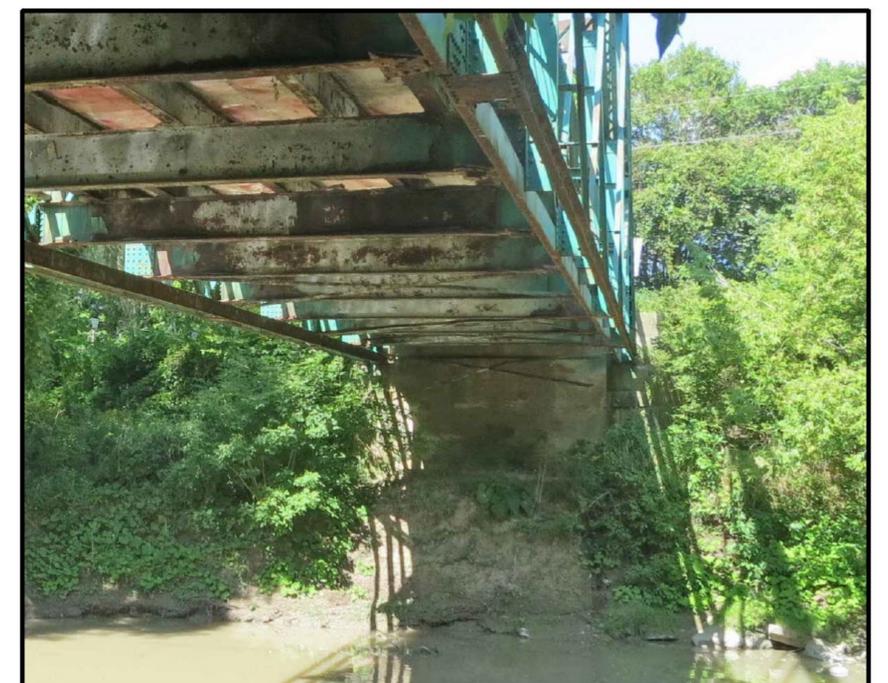
The existing Meeks bridge was built in 1900. It currently has a load posting of 8 tonnes due to multiple structural deficiencies including but not limited to:

1. Steel truss structure's bottom chords (2xC230) and floor beams (W460x67) exhibit section loss due to rusting and deterioration. Most floor system cross bracing members have fallen off on numerous panels and also have section loss;
2. Typically steel manufactured circa 1900 has a significantly lower yield strength than modern steels. The specified yield strength is most likely 180 MPa compared to 350MPa min. required strength and this dramatically affects the structural capacity of the bridge;
3. Concrete deck exhibits spalling, cracking and severe scaling;
4. Abutment condition and age of concrete used on the substructure creates a challenge for rehabilitation. Based on the year the bridge was built, the substructure concrete would not have been air-entrained and is prone to spalling and scaling due to corrosion of reinforcing bars and freeze thaw action.

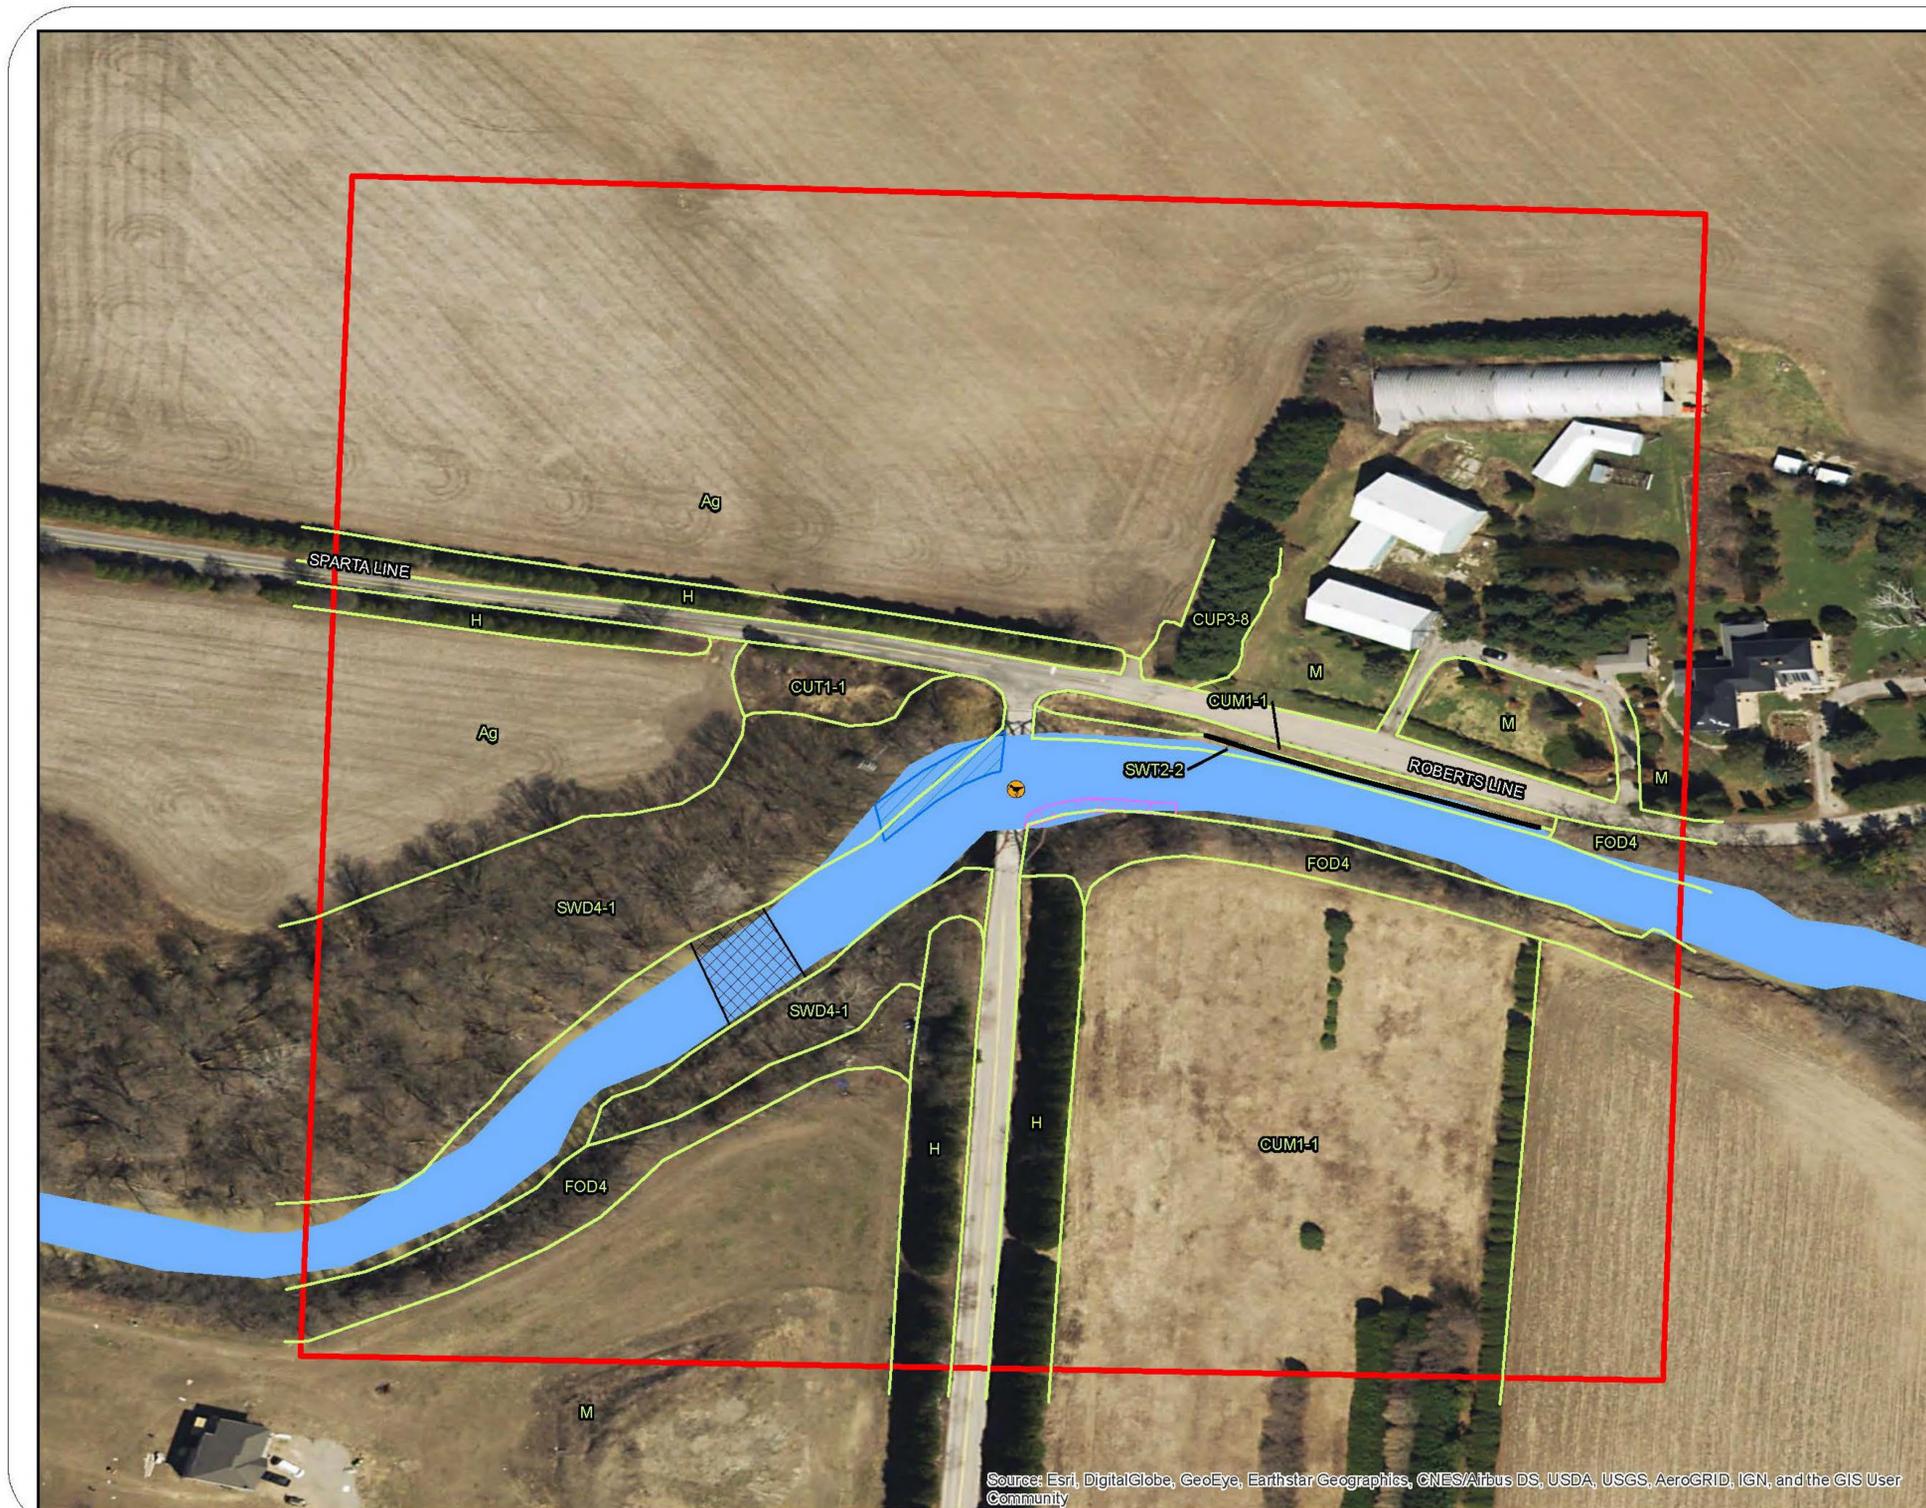
Project: TA8986	Figure: 4
Date: July, 2020	Prepared By: JJP
Scale: 1 : 1,400	Checked By: LRE

- Vegetation communities surrounding the bridge are comprised of a mix of deciduous forest, swamp and culturally influenced community types
- No species at risk plants were observed

## FIELD INVESTIGATION RESULTS

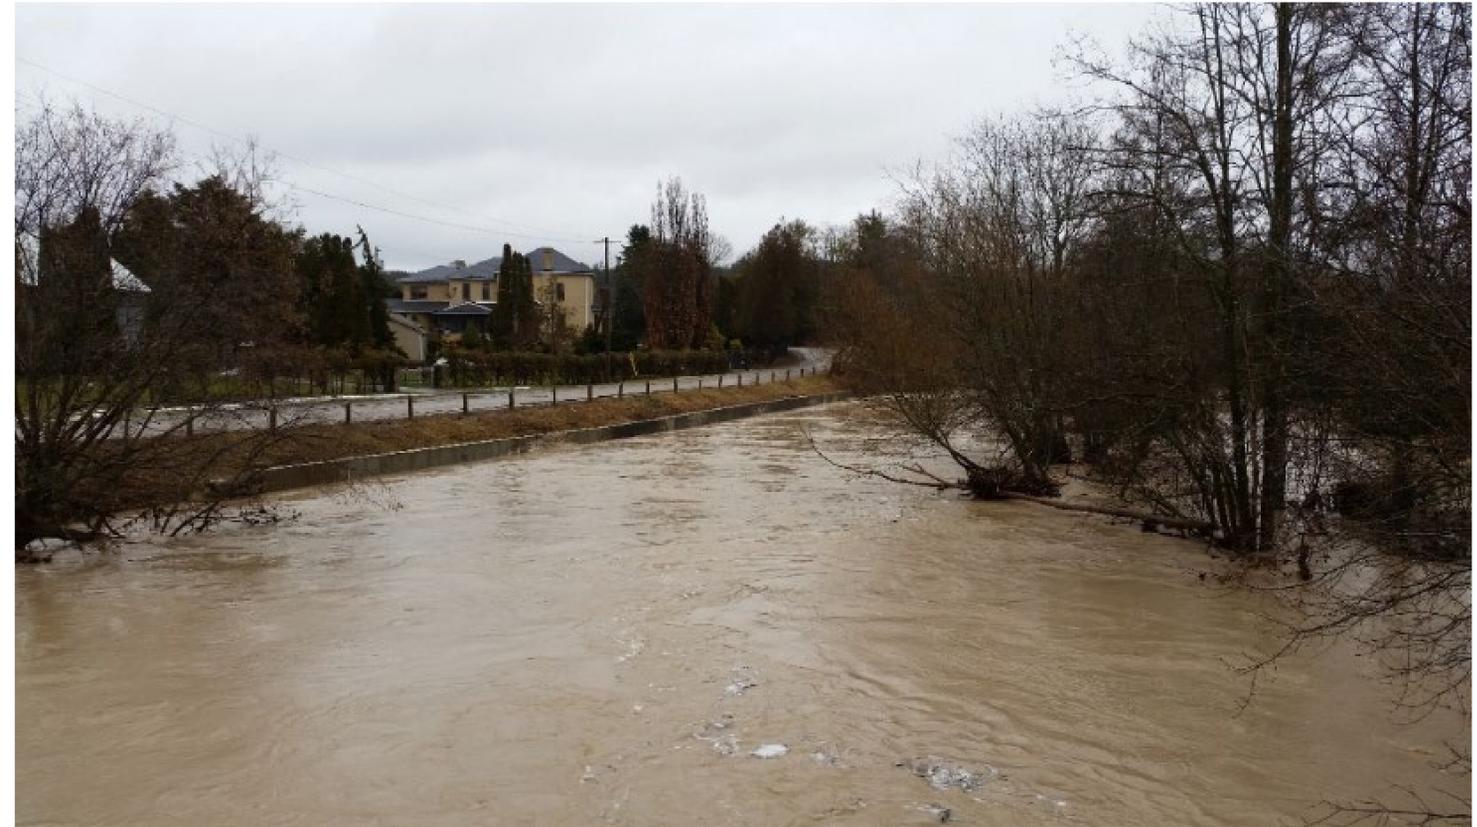
- The existing bridge passes the clearance criteria for the 25-year design storm
- The bridge can convey up to the 25-year flow with 0.25m of freeboard (clearance)
- During the regional storm, the roadway running east west parallel to Kettle Creek upstream of the bridge (Sparta Line/Roberts Line), as well as the roadway south of the bridge (Sparta Line) and farmland to the north is overtopped
- On February 20, 2018, there was a storm event which created flows which climbed near the top of the retaining wall on the north bank downstream of the bridge

February 2018 Storm – Water Levels at Retaining Wall Downstream of Bridge

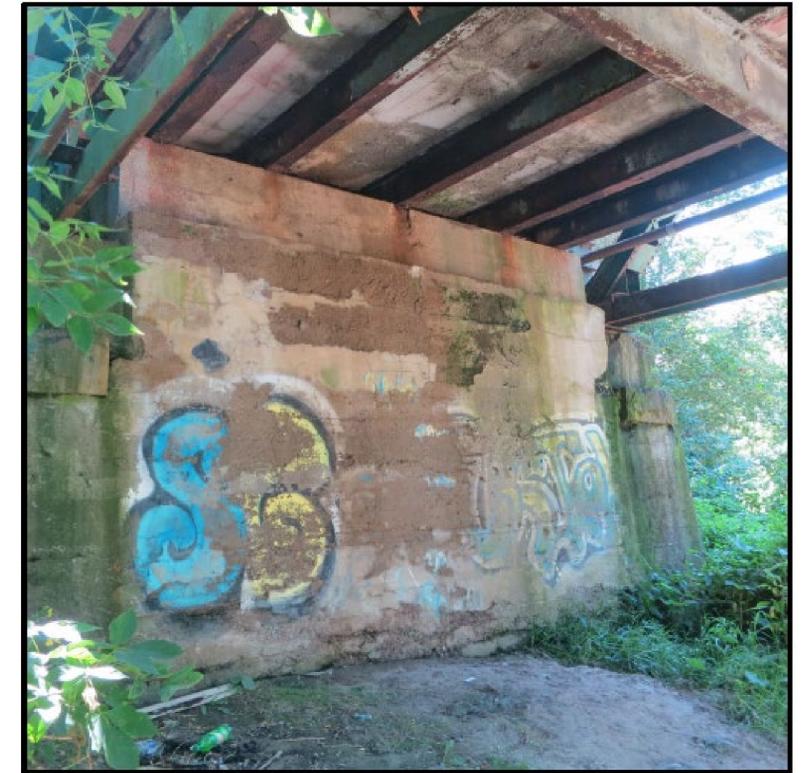
South Bridge Abutment

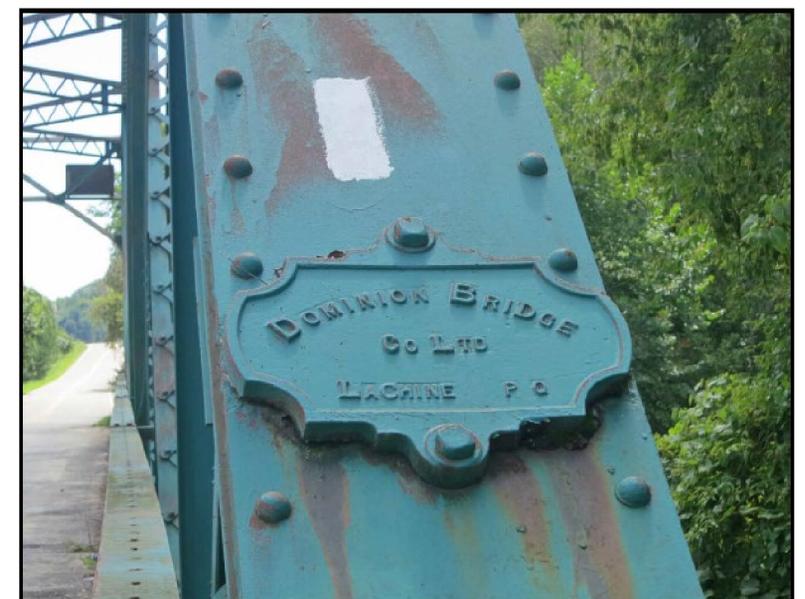
Maker's Plaque on the Northwest End Post

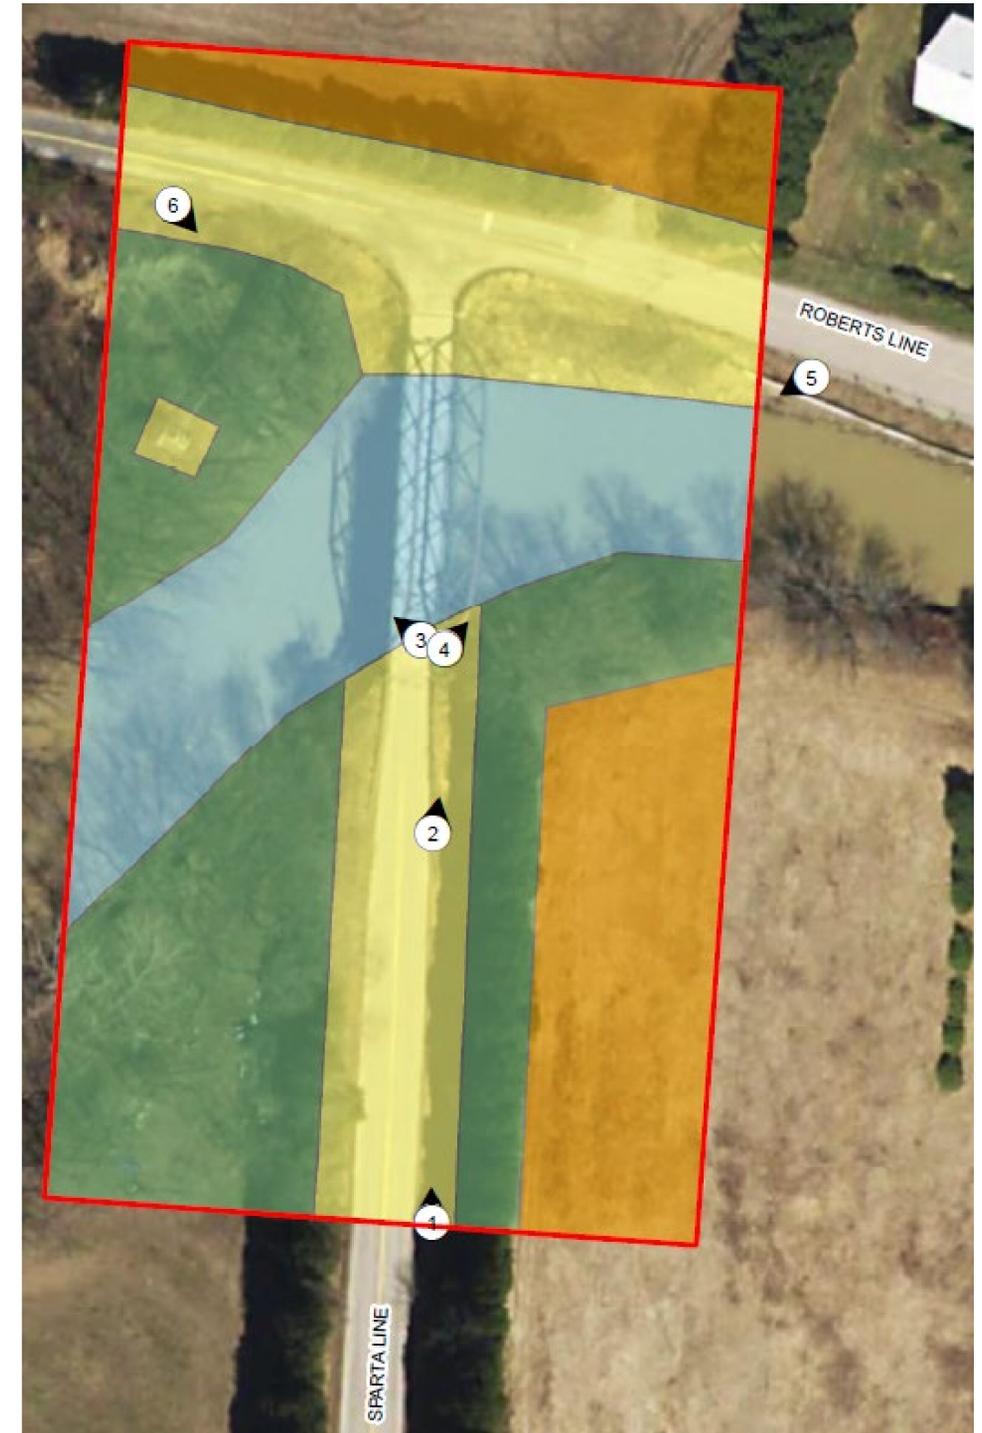
- A Stage 1 Archaeological Assessment was conducted for the study area
- The assessment concluded that portions of the study area may require a Stage 2 Archaeological Assessment should the proposed work extend into these areas (shown in green and orange)
- The remainder of the Study Area does not retain archaeological potential on account of deep and extensive land disturbance, low and wet conditions

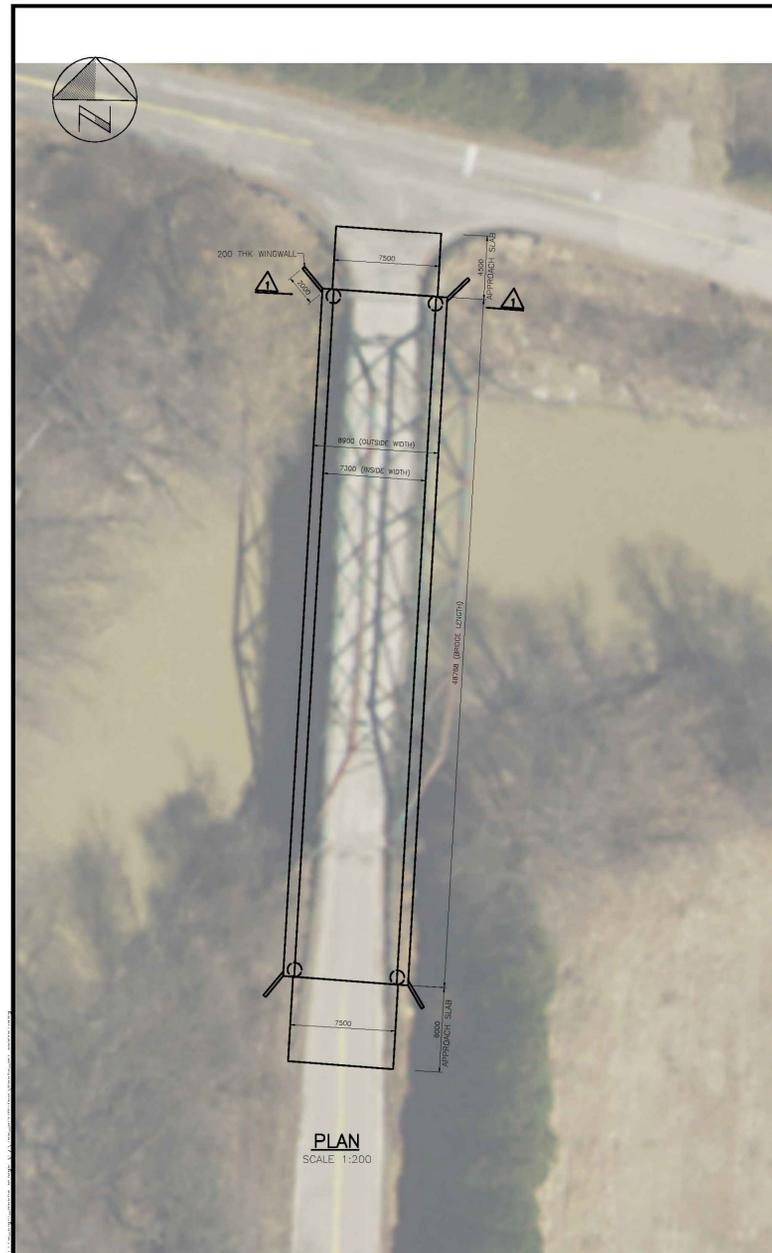
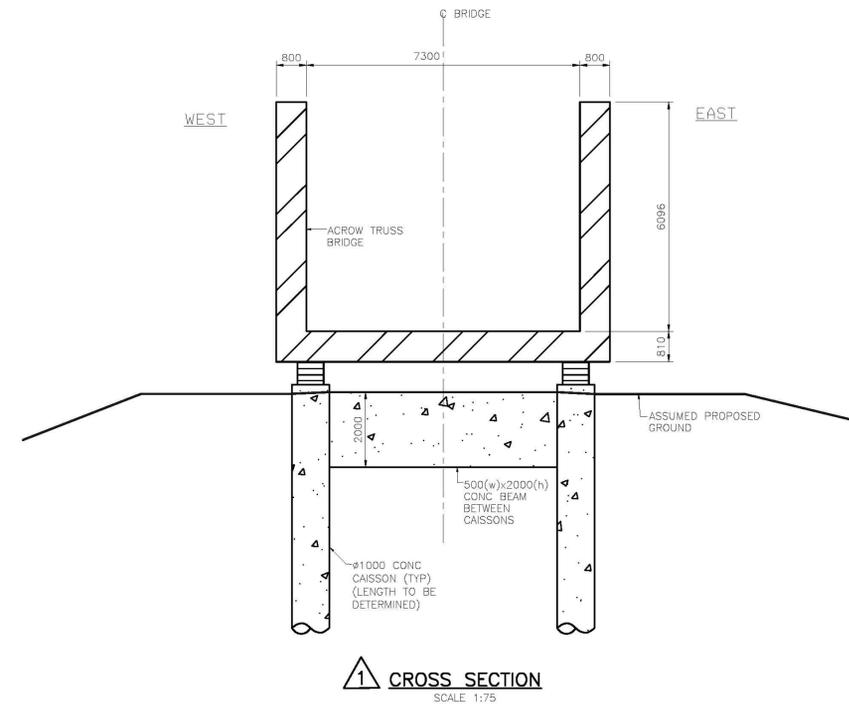
- Option 2 - 140 ft (42.5m) span was selected as the preferred alternative as the new bearings can be located behind the existing abutments and founded on piles or caissons.

- The existing abutments can remain in place but be modified to allow the Port Bruce bridge to pass over them.
- Using a 130 ft (39.6 m) span (Option 1) would have required extensive modification to the existing abutments and this is noted as being a high-risk option as the condition of the existing abutments has not been assessed to determine the potential extents of modification required (noting they are 120 years old).

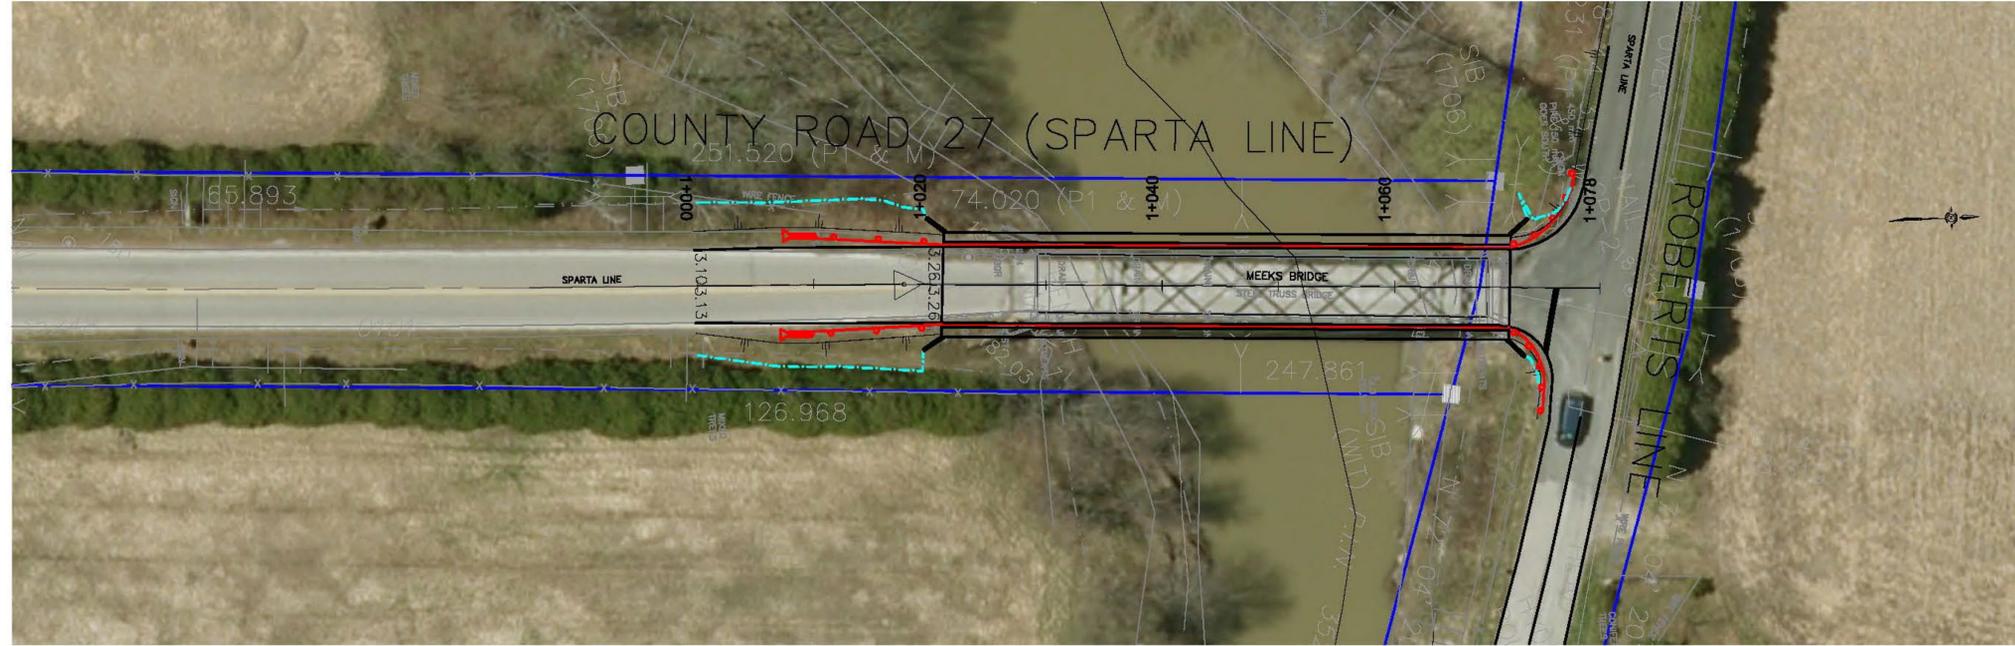
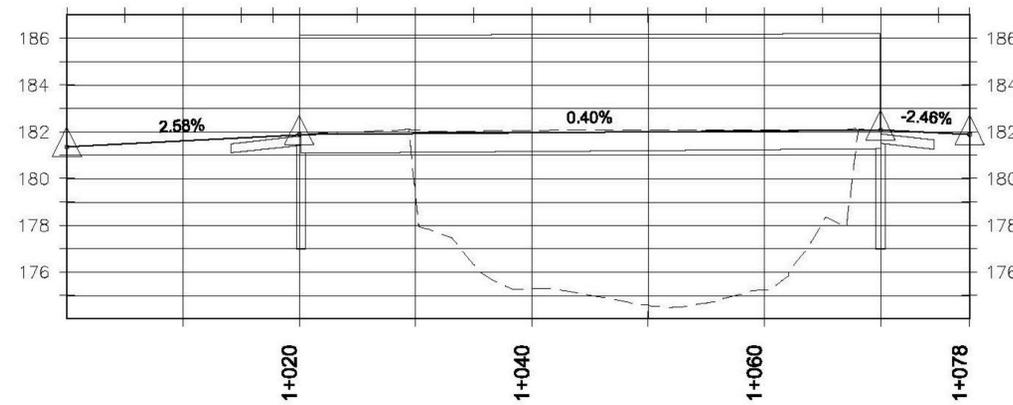
DRAWING NO.  
1

County Road 27 PROFILE

COUNTY OF ELGIN  
REPLACEMENT OF MEEKS BRIDGE  
FUNCTIONAL DESIGN
