County of Elgin

Meeks Bridge Replacement Municipal Class Environmental Assessment

Project File Report

September 2020

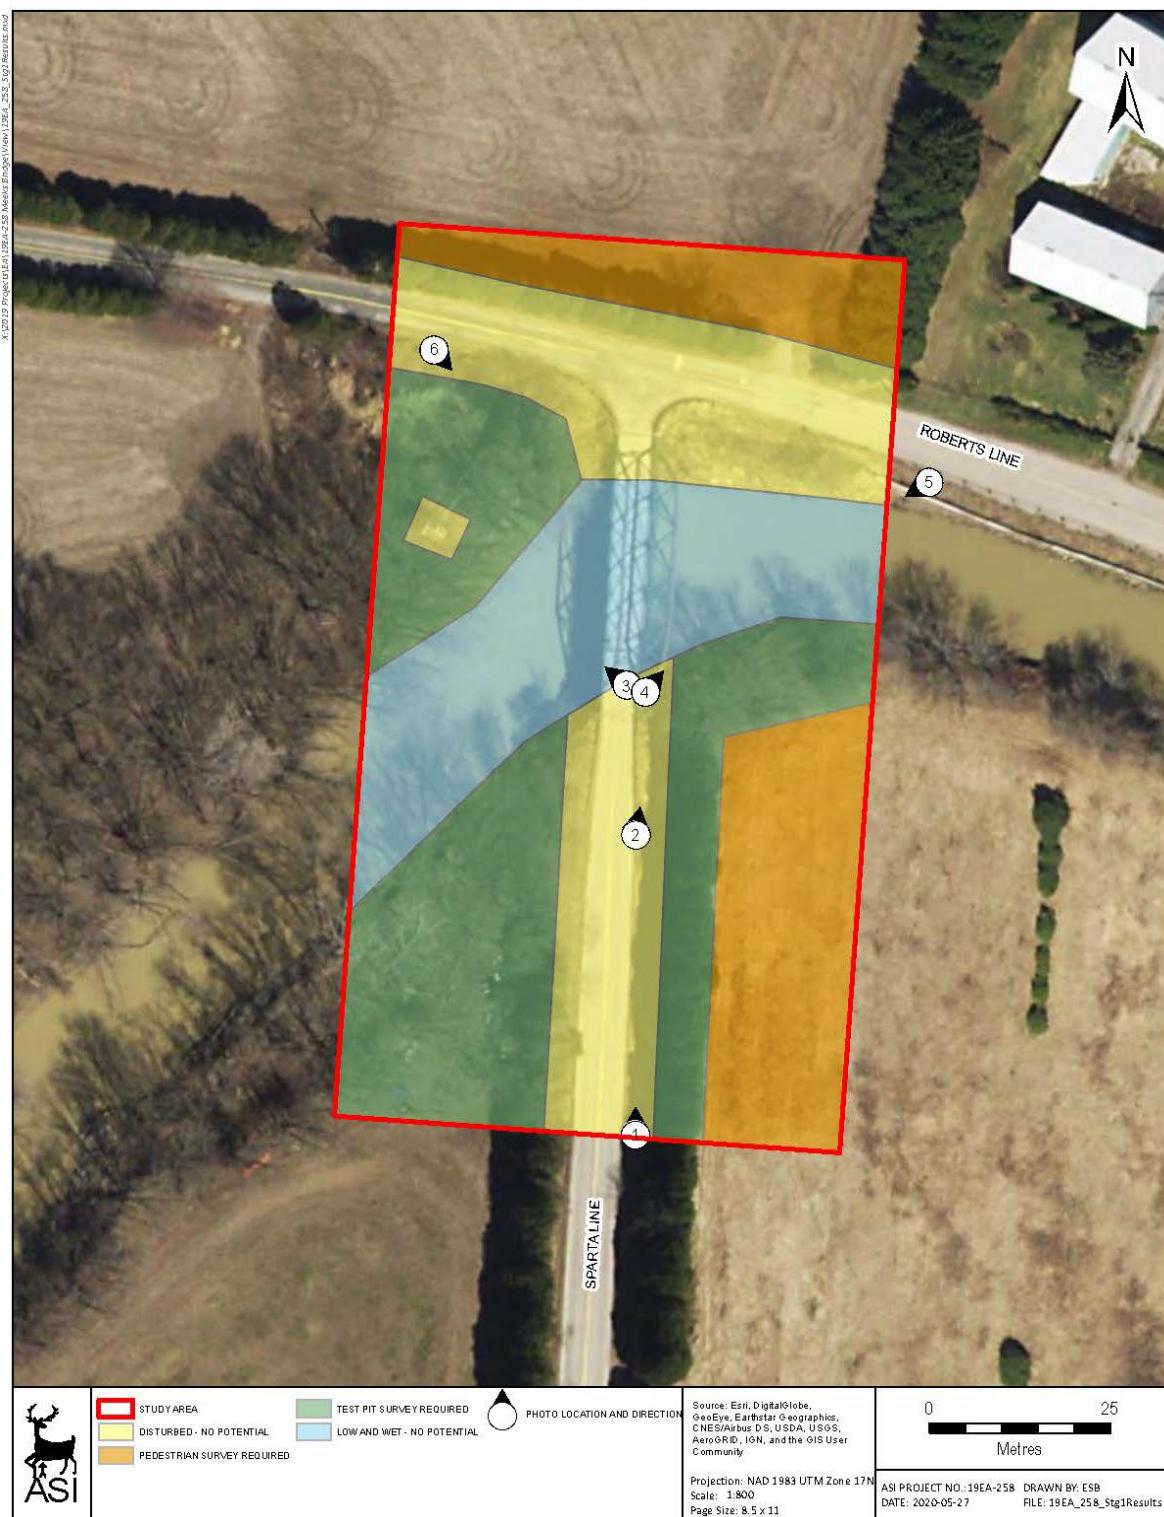
Figure 2-1: Stage 1 Archaeological Assessment Findings

1. The study area exhibits archaeological potential. If impacted, these lands require Stage 2 archaeological assessment by test pit/pedestrian survey at five metre intervals, where appropriate, prior to any proposed construction activities;
2. The remainder of the study area does not retain archaeological potential on account of deep and extensive land disturbance, low and wet conditions. These lands do not require further archaeological assessment; and,
3. Should the proposed work extend beyond the current study area, further Stage 1 archaeological assessment should be conducted to determine the archaeological potential of the surrounding lands.

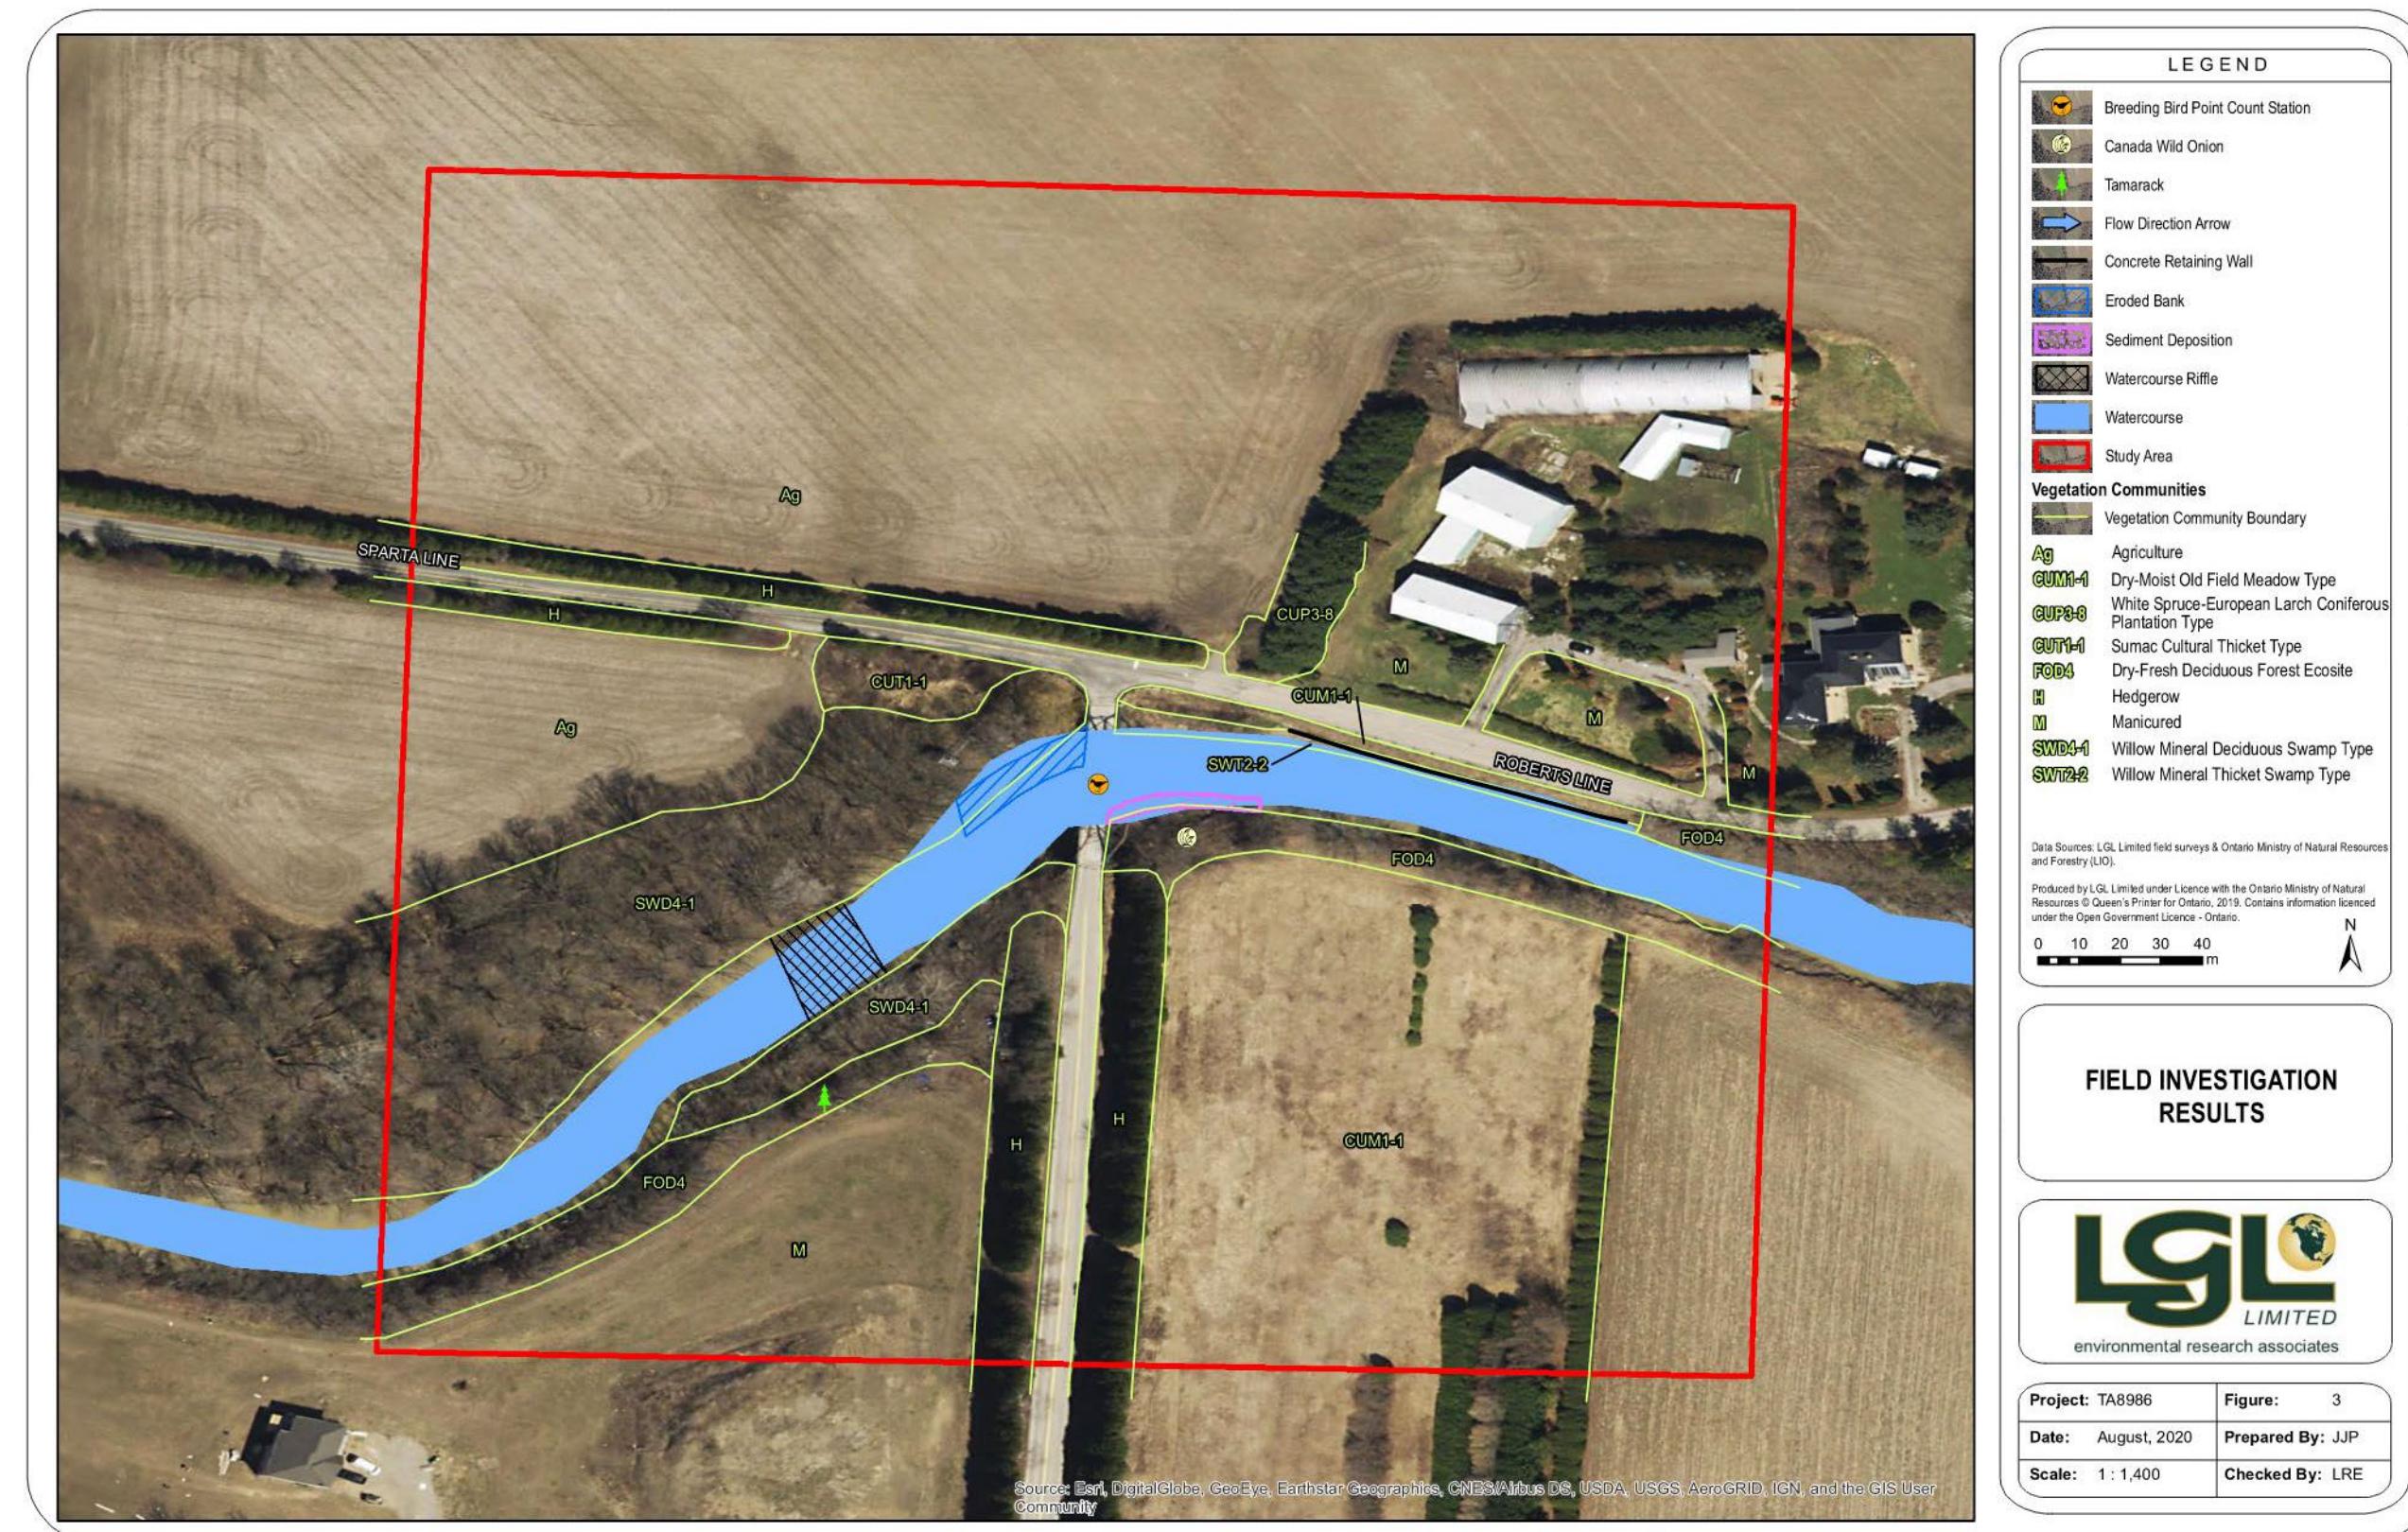
Figure 2-3: Natural Heritage Field Investigation Results

The riparian areas along the banks of Kettle Creek are identified as being significant woodlands and significant valleylands. A vegetation survey was conducted on June 22, 2020 to investigate the extent of the vegetation communities occurring in the vicinity of Meeks Bridge. Natural and semi-natural vegetation features identified within the study area were classified according to the Ecological Land Classification for Southern Ontario as illustrated in Figure 2-3. The following natural and semi-natural communities are found in proximity to Meeks Bridge: Black Locust Deciduous Forest (FOD4); Willow Deciduous Swamp (SWD4-1); Willow Thicket Swamp (SWT2-2); White Spruce Cultural Plantation (CUP3-8); Sumac Cultural Thicket (CUT1-1); Old-field Cultural Meadow (CUM1-1); and, various Eastern White Cedar Hedgerows (H).

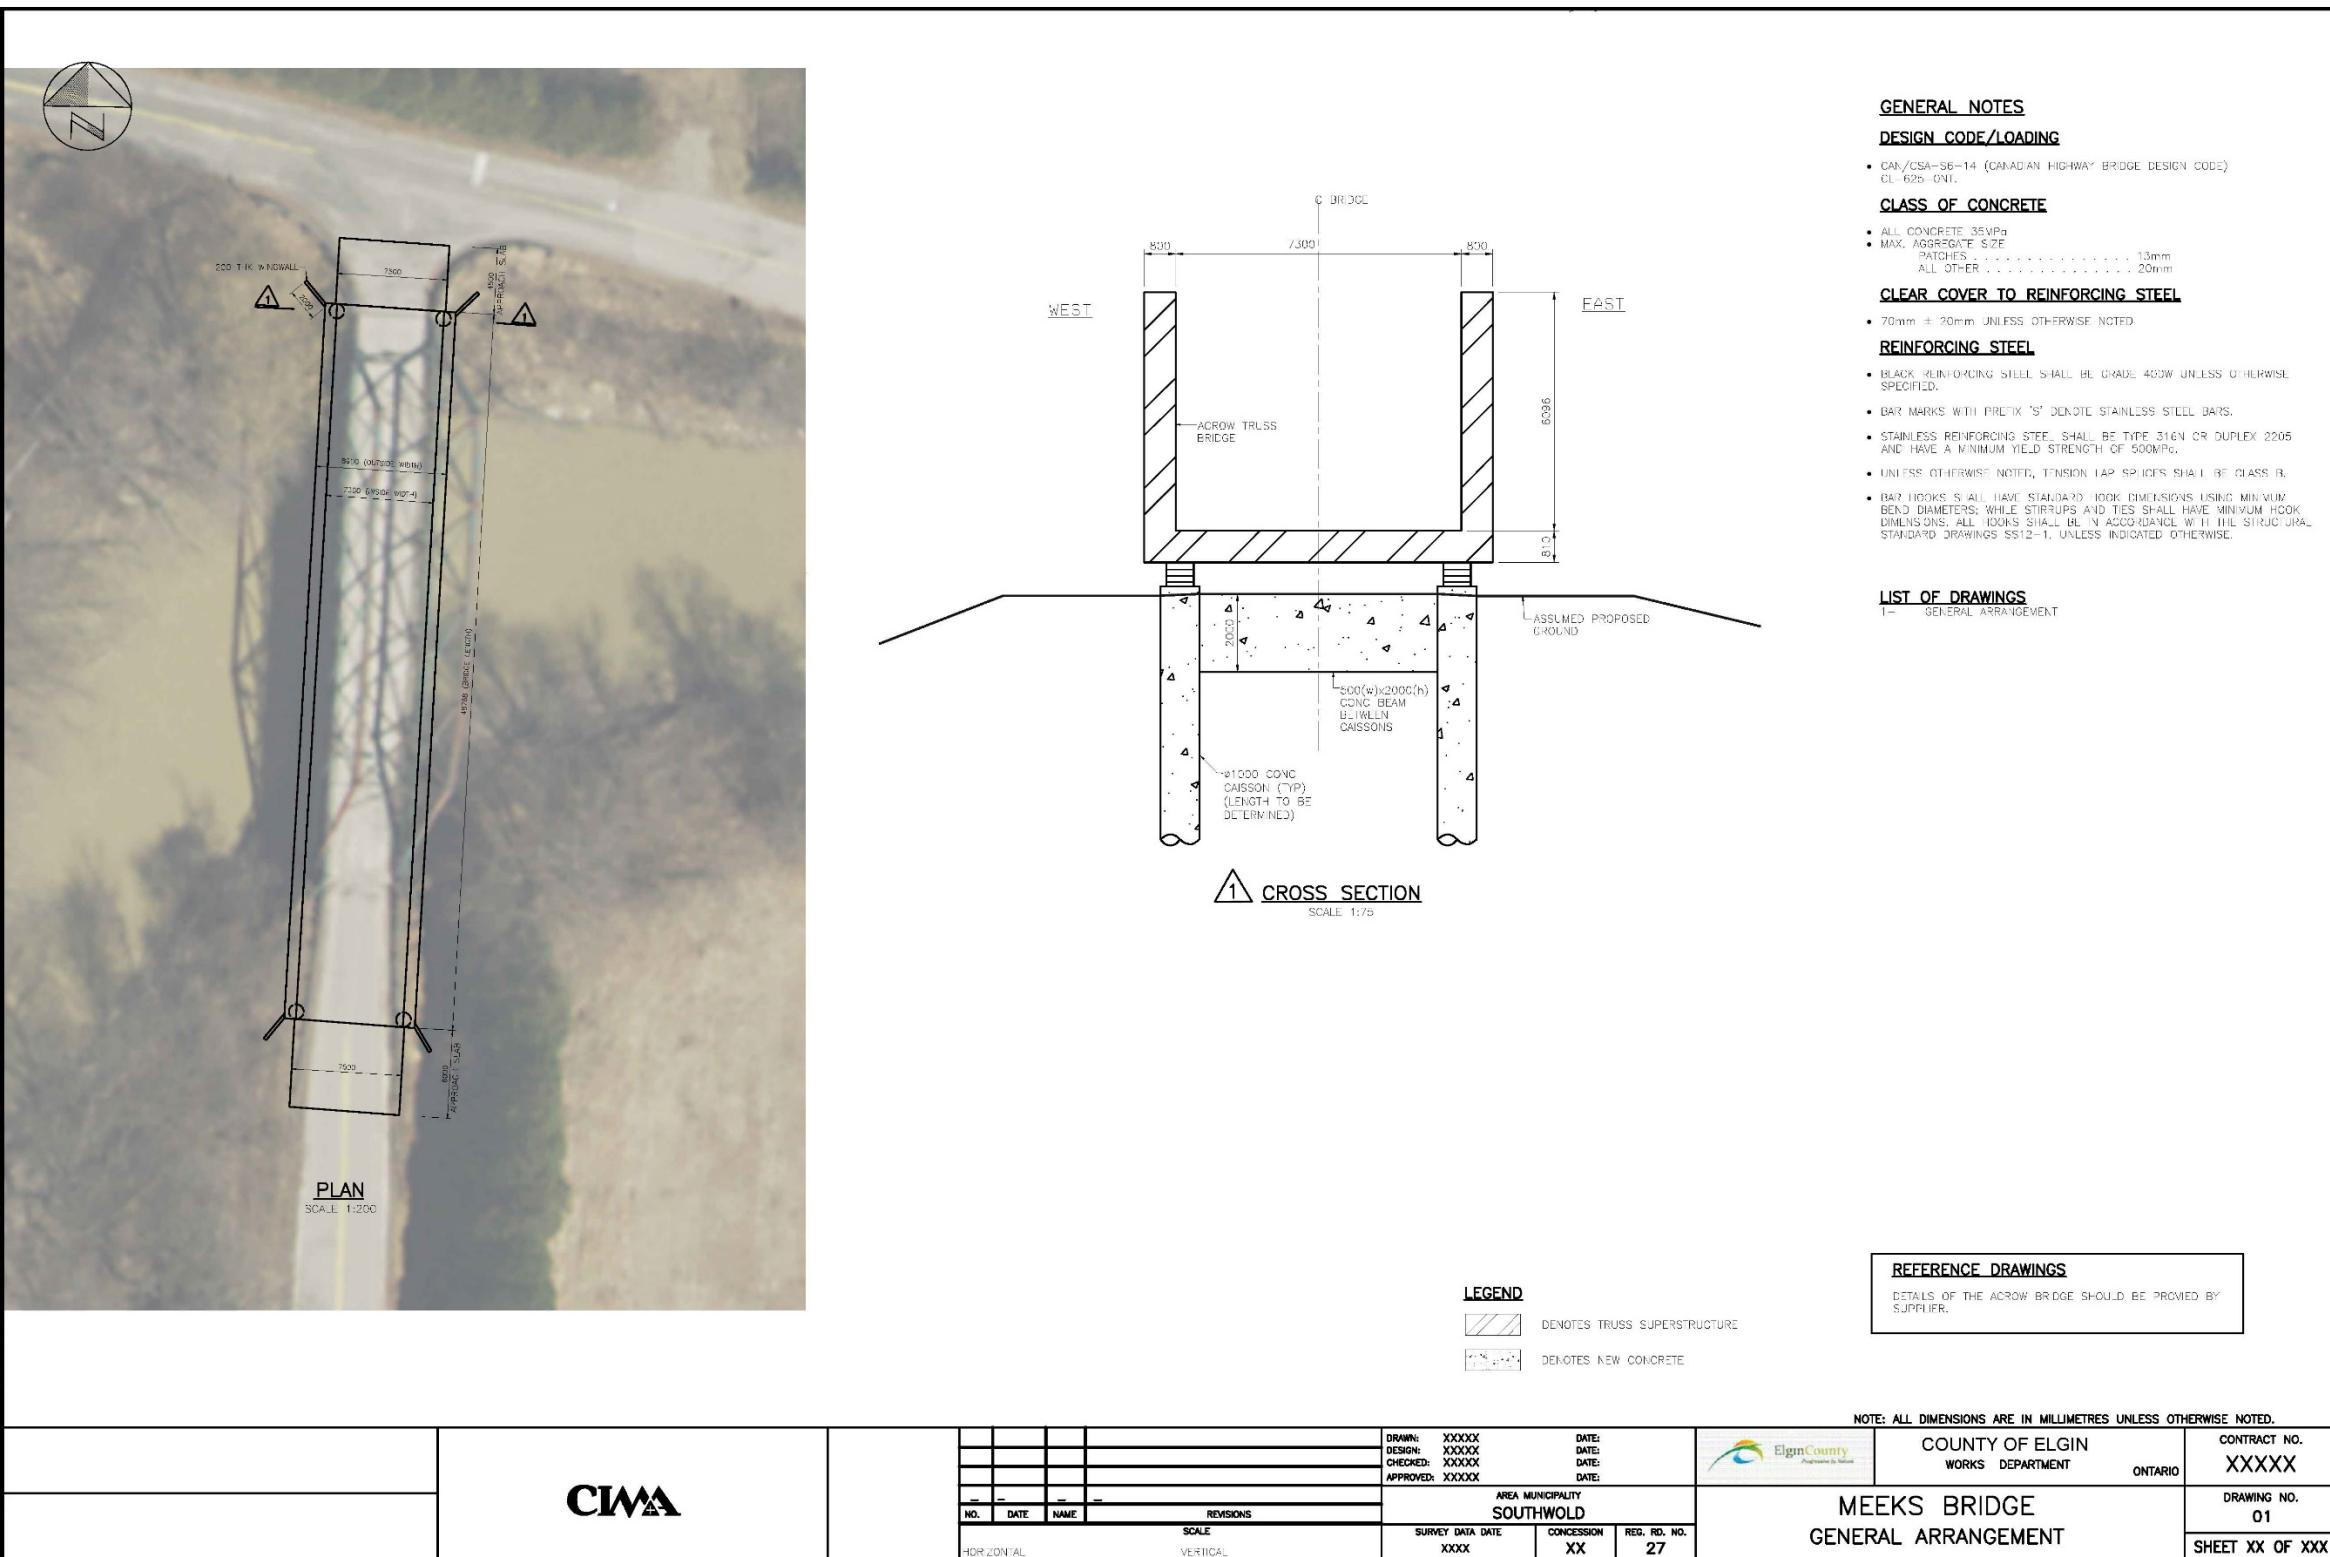
Figure 5-1: General Arrangement

The replacement bridge will have a 140-foot (42.5 metre) span. For a 140-foot span bridge (14 bays at 10 feet), the new span length will be approximately 42.5 metres, which is approximately 3.8 metres longer than the existing 38.7 metre span length. The new bearings will be located behind the existing abutments and founded on piles or caissons. The existing abutments will remain in place but be modified to allow the Port Bruce bridge to pass over them.

The Port Bruce temporary modular panel bridge (by Acrow Technology) will be utilized to replace the Meeks bridge superstructure. The Port Bruce bridge is currently a single lane having a 54.8m +/- span, c/c bearings distance of 6.7m and 5.29m +/- wide with an epoxy aggregate anti-skid coated steel deck. The Port Bruce temporary modular bridge's width can be adjusted to provide various lane widths. The bridge's span length can be adjusted in 3.05 metre (10 foot) increments and as such it cannot be reduced to match the existing 38.7 metre (126.97 foot) span of the existing Meeks bridge. Adjusting the width is achieved by purchasing and installing new bridge components from Acrow.

The general arrangement drawing for the Meeks Bridge replacement is provided as Figure 5-1.

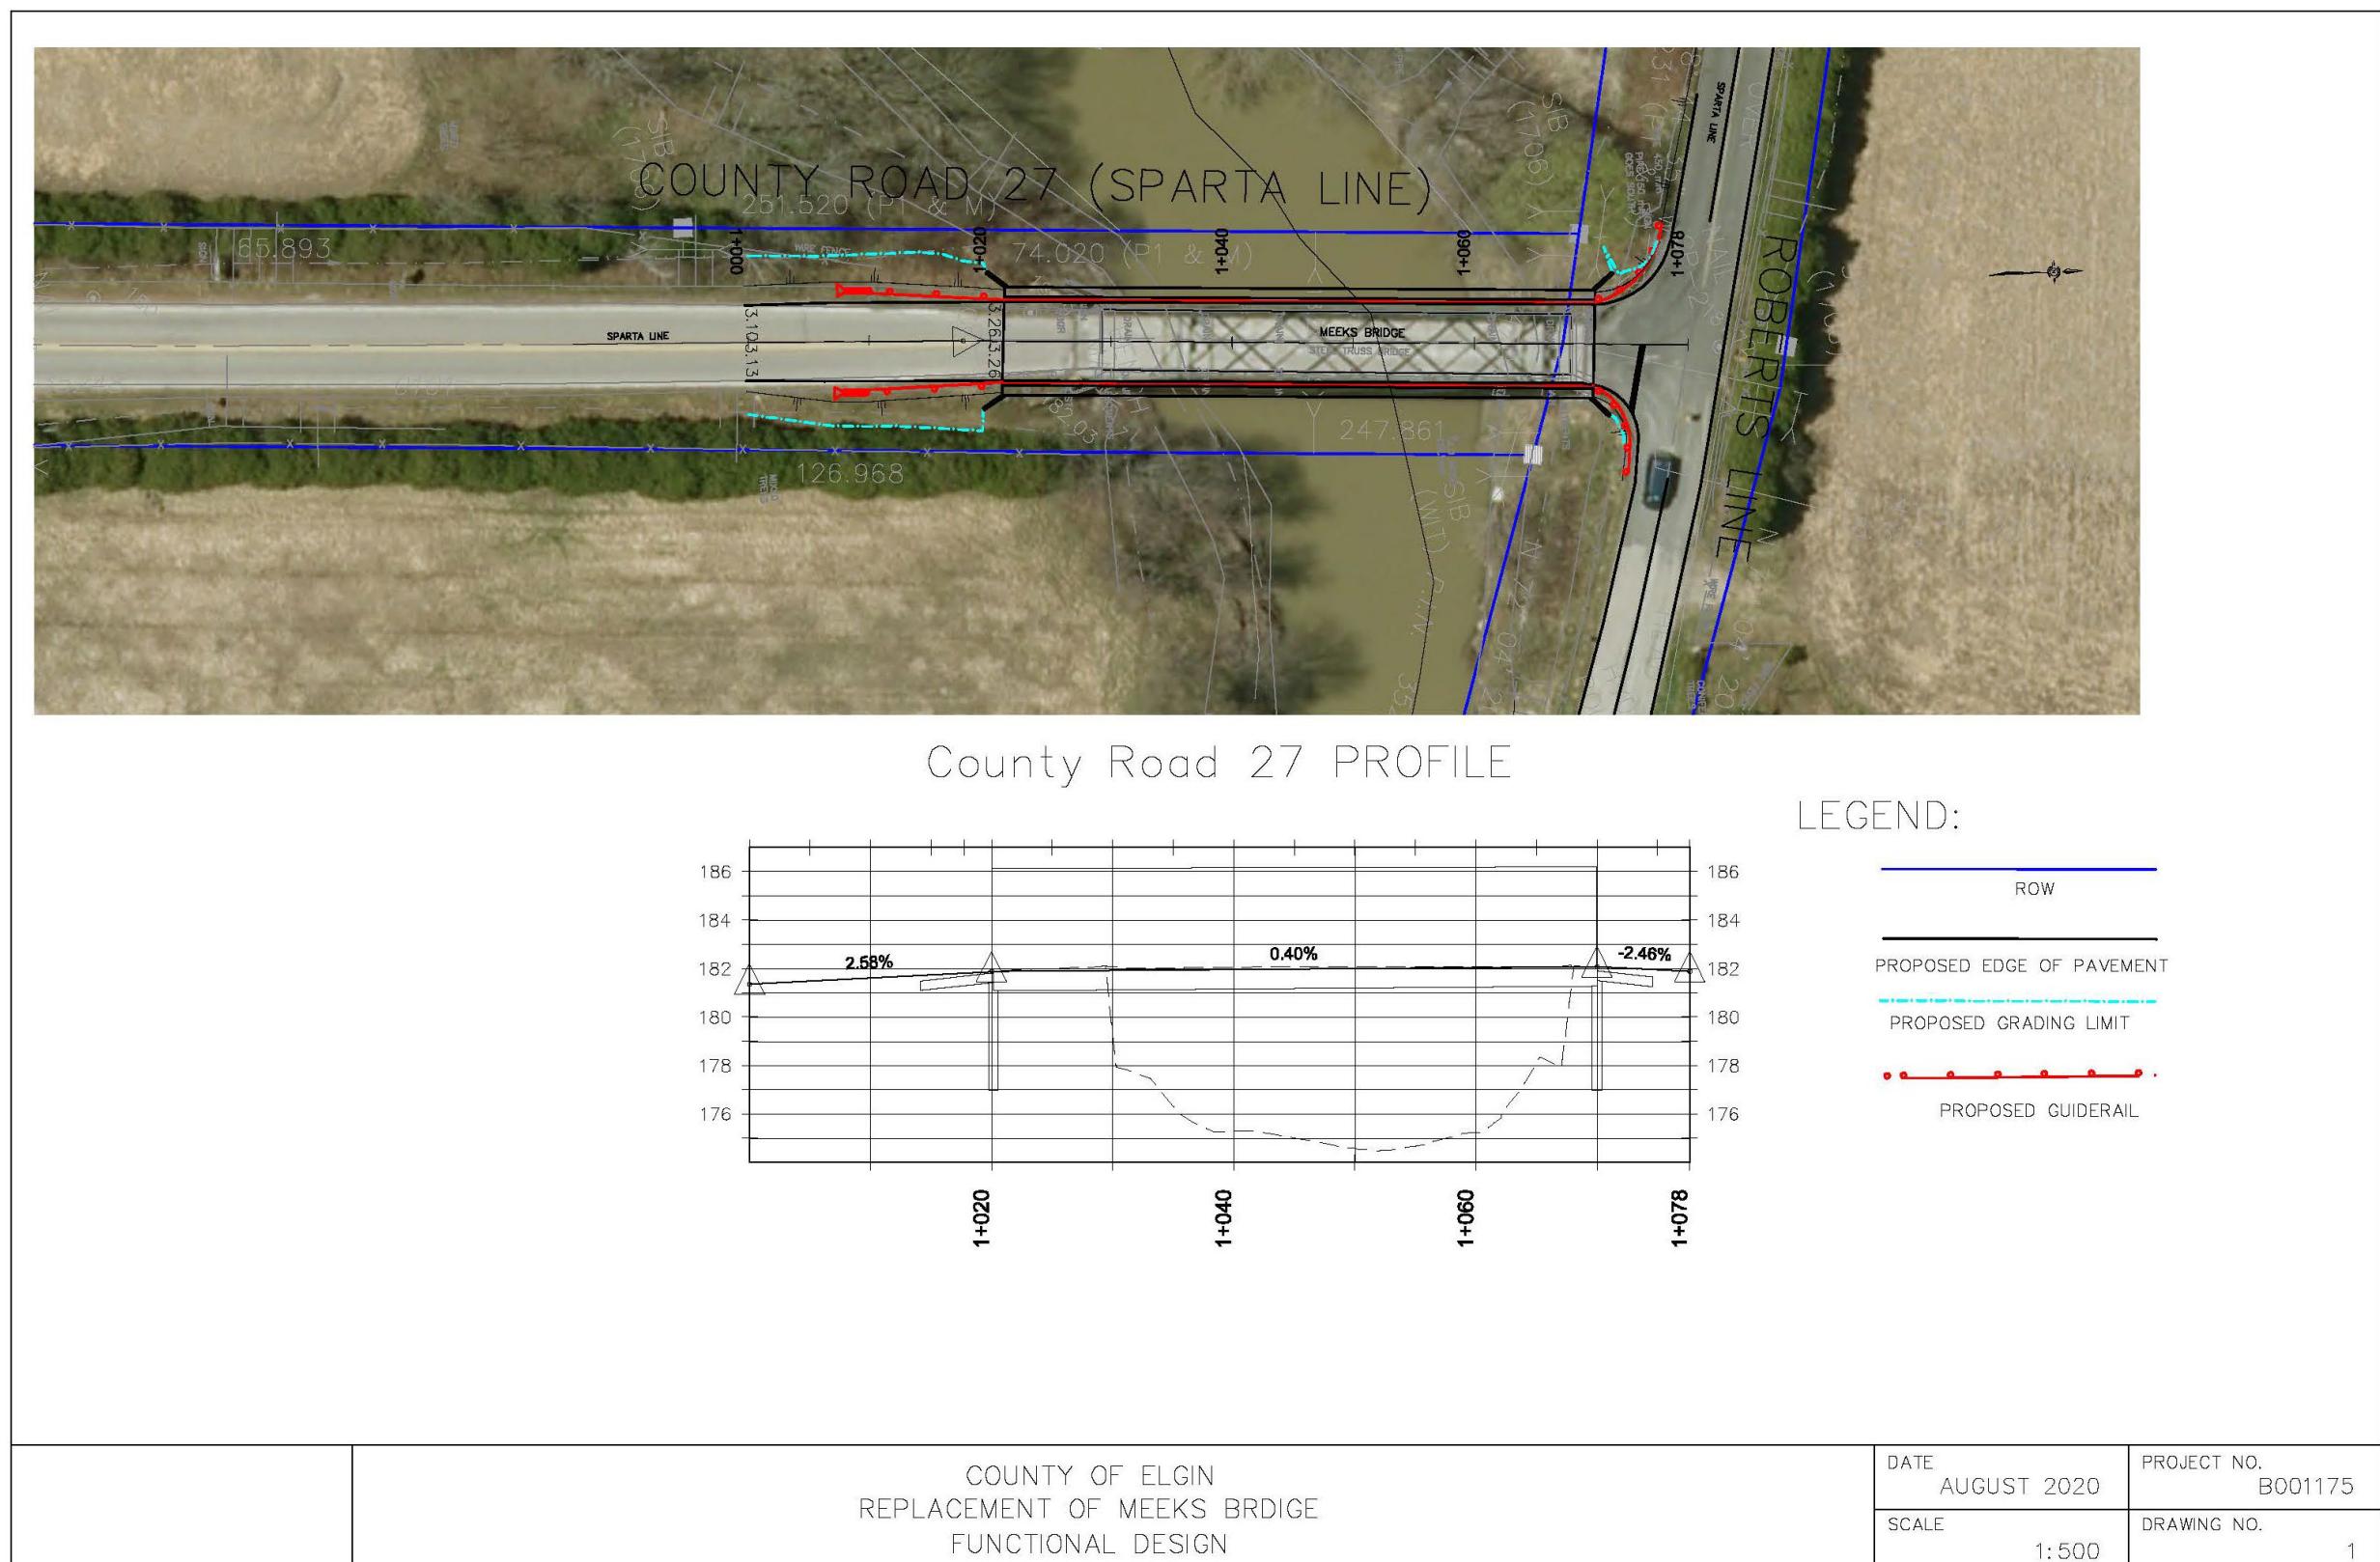
Figure 5-2: Functional Design

As part of the Meeks Bridge replacement, the Trust to Truss width across the bridge will be 7.3 metres. Two ~3.25 metre traffic lanes will be provided over the bridge. Currently Sparta Line on the south approach has two 3.25 m wide lanes but narrows close to the approach to the existing 1-lane bridge. A localized widening of the south approach (~ 20 metres) is required to match the 3.25 m wide lanes. No active transportation facilities will be provided along Meeks Bridge as there is no active transportation connection upstream or downstream of the bridge.

The guiderail on the northwest corner of the Sparta Line and Roberts Line intersection will be extended and end treatments will be added. End treatments will also be added to the south end of the guiderail on both sides on the road. The grading adjacent to the end treatments will be 3:1 (subject to review in the detail design stage).

The functional design for the Meeks Bridge replacement is illustrated in Figure 5-2.
